# Analysis of Starship third and fourth flights main results

Yu. I. Lobanovsky

## Summary

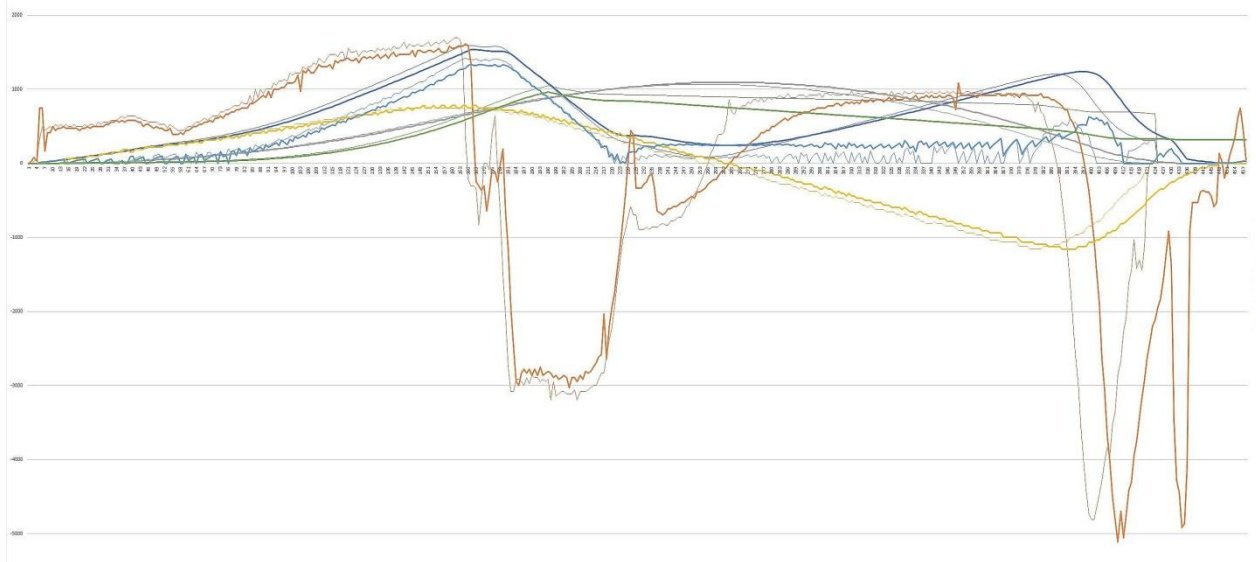
**Fig. 1 – Acceleration, speed, altitude and direct (horizontal) range, as well as horizontal and vertical speed components of Starship booster in the third and fourth flights [4]**

However, if you look at Fig. 1 and compare acceleration graphs for the third and fourth flights during the boostback, you can see that both the maximum acceleration values and the engine operating time in this mode are almost identical, and it is very difficult to understand from this that 6 engines shut down prematurely during IFT-3. And masses of the boosters during the boostback in both flights should have been approximately the same, since the intermediate compartment weighing about 9 tons was dropped during IFT-4 2 seconds after the engines stopped working. So the thrust of the power plant during the fourth flight, if it was less, was very insignificant, and to fully resolve the issue of the possibility of Pogo inducing at the very end of the boostback during IFT-3, more complete and accurate data are needed than those in the public domain. It also becomes clear that the information in the SpaceX release about the final part of IFT-3, as usual, doesn't quite correspond to reality.

But, from a comparison of the graphs in Fig. 1 and the iconography of the video streams, it is quite possible to conclude that during the IFT-4 boostback, SpaceX followed the path already tested during IFT-3 on the second stage of the rocket system: if the boundary of Pogo excitation zone is reached by the rocket system shortly before the end of the next phase of power plant operation, then at this moment the control system turns off those engines whose characteristics have approached Pogo zone, and the final impulse is realized by the remaining part of the engines, which have a different length of the fuel component supply lines, and which, therefore, are quite capable of continuing to operate without exciting self-oscillations. This has already been done twice at the finish of the second stage acceleration, when 3 more efficient Raptor-2 engines with a vacuum nozzle were turned off approximately 15 seconds before the end of the stage acceleration during IFT-3 and 28 (!) seconds during IFT-4, and only 3 central engines with conventional nozzles continued to operate, see Fig. 2. During the boostback at IFT-4, all 10 engines of the inner ring of the booster were switched off in advance and in an organized manner (symmetrically in two groups of 5 engines) over a fraction of a second, and its final acceleration towards the launch site over 8 seconds was carried out only with the help of 3 central engines [1]. While at IFT-3, the engines were randomly switched off over the same 8 seconds. The last to switch off were 3 central engines, but their delay compared to the last engine of the inner ring was only about 1 second [10]. Moreover, their shutdown occurred asymmetrically, which deflected the booster's flight speed vector and put it on an unplanned, steeper and shorter return trajectory with the point of impact twice as far from the launch site as planned.

From Fig. 1 it follows that the maximum inertial acceleration of B11 booster during landing was about 50 m/s<sup>2</sup>. Its mass at this time should have been 9 tons less than that of B10 booster, due to the fact that during IFT-4 the intermediate compartment was jettisoned by this time. In addition, it was determined from the video that the fall speed of B11 booster by the time the engines were turned on was approximately 330 m/s, and that of B10 booster was 370 m/s. Therefore, during IFT-3 the inertial acceleration should have been about 56 m/s<sup>2</sup>, and the total, taking into account the gravitational acceleration, about 66 m/s<sup>2</sup>, but not 80 m/s<sup>2</sup> as in the first estimates presented in [3]. Then the thrust of the power plant should have been 15.2 MN, and the throttling ratio of these engines for thrust in this mode should have been about 0.52. And taking into account that the thrust falls somewhat faster than the pressure in the main combustion chamber of the engine decreases, we will consider the degree of throttling by pressure to be equal to  $\sim 0.55$ . Then the ratio of pressure on the oxygen pump will be  $p_2/p_1 \approx 92.5$ .

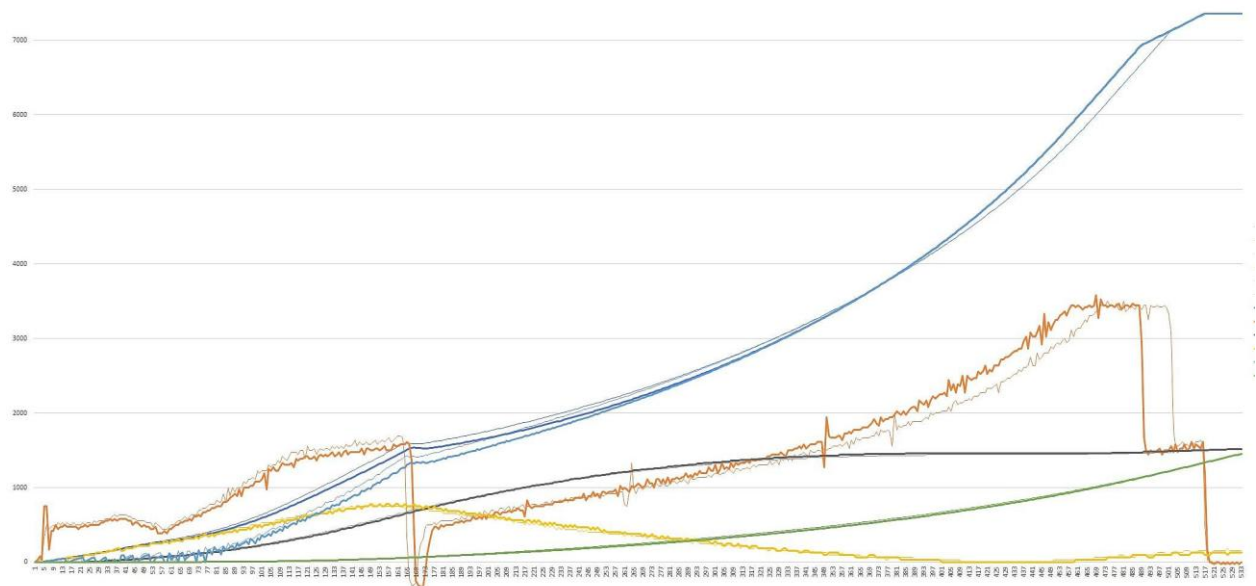
**Fig. 2 – Acceleration, speed, altitude, direct range, as well as horizontal and vertical velocity components of Starship second stage in the third and fourth flights, including as part of stack [4]**

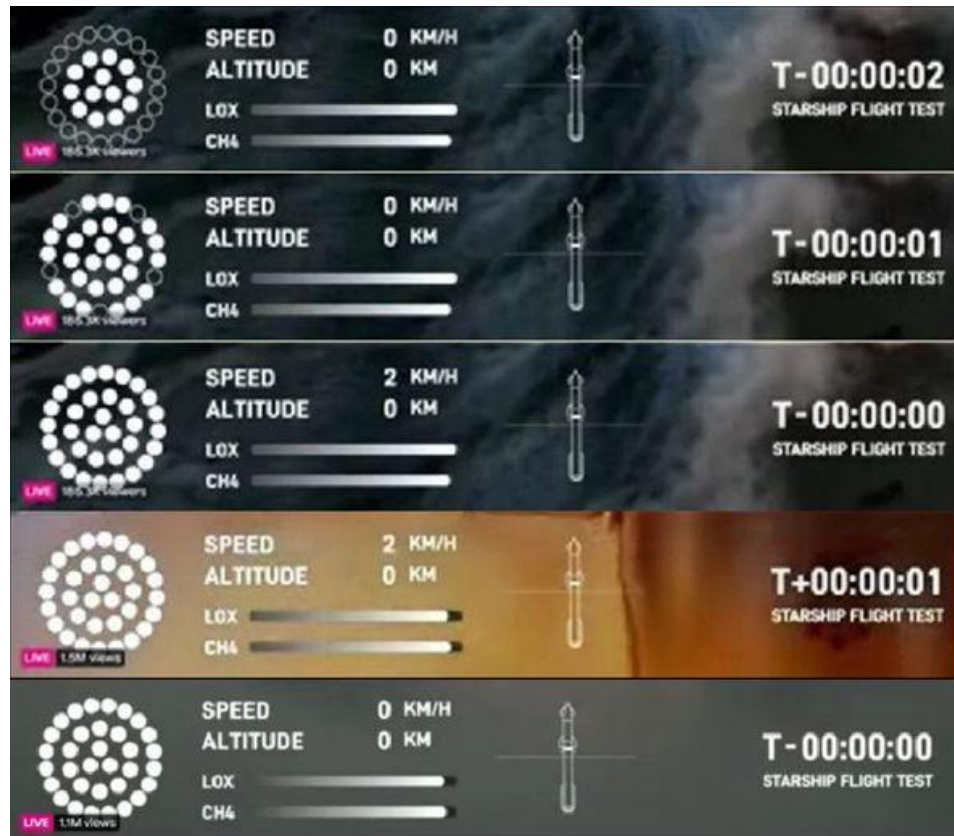
Fig. 3 – Iconography of engine activation at takeoff for Starship last three flights

This is confirmed by the iconography that was shown in the video streams of all three flights under consideration. When Starship is launched, the inner 13 engines are first fired, then, after a second delay, the 15 engines of the outer ring, and then, after about another second, the remaining 5 outer engines, see the first 3 fragments at the top of Fig. 1 from the stream of the second launch. They show the moments in time when the iconography with corresponding quantity of operating engines first appears.

In the third flight, the iconography generally coincided with what happened in the second flight, but all engines were turned on a second later (see the fourth fragment of Fig. 3), and the rate of thrust buildup was initially noticeably behind the rate in the second flight, and then began to noticeably outpace it, and the auto-oscillations of Pogo didn't have time to develop during this transient mode of engines operation. But in the fourth flight (see the fifth, lower fragment of Fig. 3), there was a return to approximately the previous engine control algorithm, and, judging by the available data, Pogo-process also returned, which led to the loss of one engine out of 33 at launch. Such inconsistency in the decisions of Starship creators is difficult to explain logically.

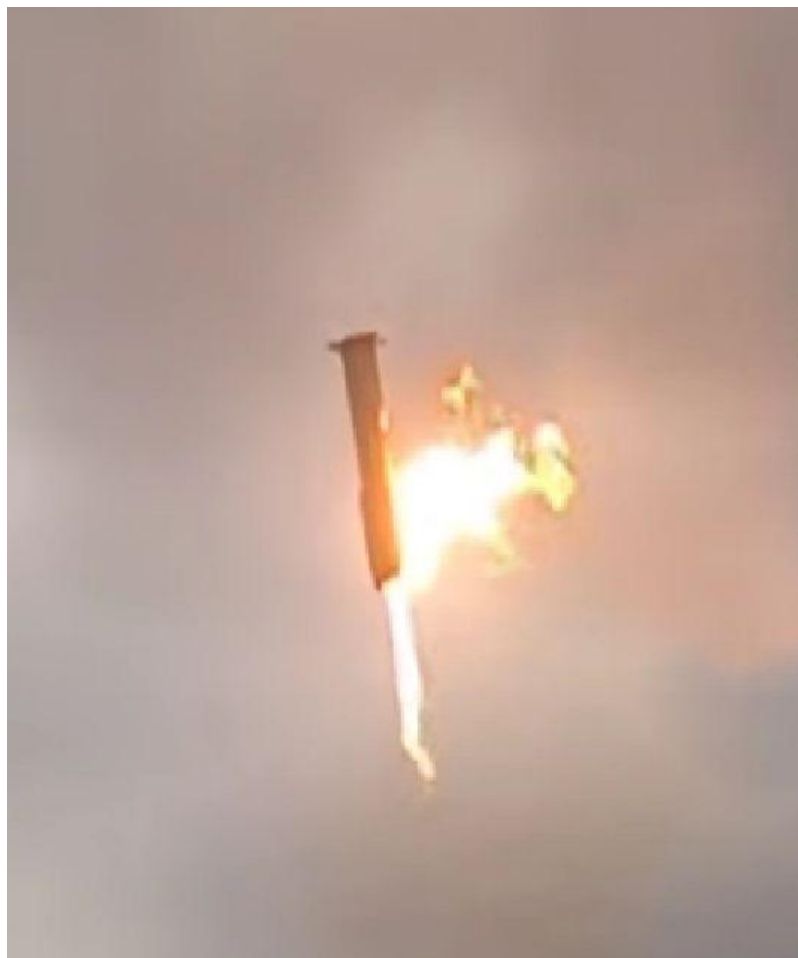
However, the adventures of B11 booster on its fourth flight not finished there. During the final braking, one of the inner ring engines, apparently damaged at the very end of the boostback, didn't turn on, and a powerful fire can be seen in the video of the booster landing on the water [11], see Fig. 4.

**Fig. 4 – Fire on B11 booster before splashdown**

Most likely, this fire was caused by the destruction of fuel lines of the very same engine that didn't turn on. Video [11] doesn't show the end of the booster landing on the water, SpaceX's message about the fourth flight [2] doesn't say anything specific about what happened to the booster after splashdown, and no one else has seen B11 booster anywhere. Therefore, it either sank quickly or exploded. From the totality of data (fire, silence from SpaceX), the most likely option is the booster explosion after landing, much like the explosion of SN 10 prototype on March 4, 2021 during testing [12].

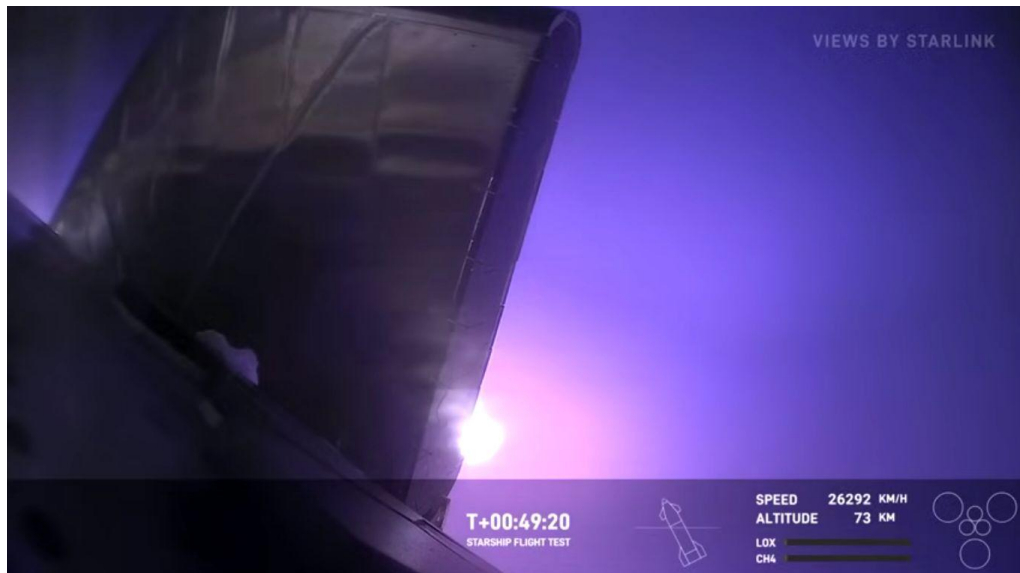
In Fig. 6 we see a picture of the flow around surface fragment of the second stage (Ship) in the vicinity of the junction of the right forward flap with the body [1]. The straight line closest to the observer is the trailing edge of the flap. Flight altitude is 73 km, speed is approximately 7.3 km/s, Mach number is about 21.5. The heating of the surface as a whole is not very high yet, the maximum heat fluxes will be reached at an altitude on 3 km lower [15]. The upper surfaces of the vehicle are dark and still relatively weakly heated, but not far from the base of flap tail edge we see a very bright area – this is the boundary layer separation zone created by bow shock, which generates a narrow area with heat fluxes that are many times greater than those in any other place of the vehicle, with the exception of a similar zone located on the left forward flap.

**Fig. 6 – Picture of hypersonic flow around the junction of hull with forward flap at the beginning of braking in the atmosphere**

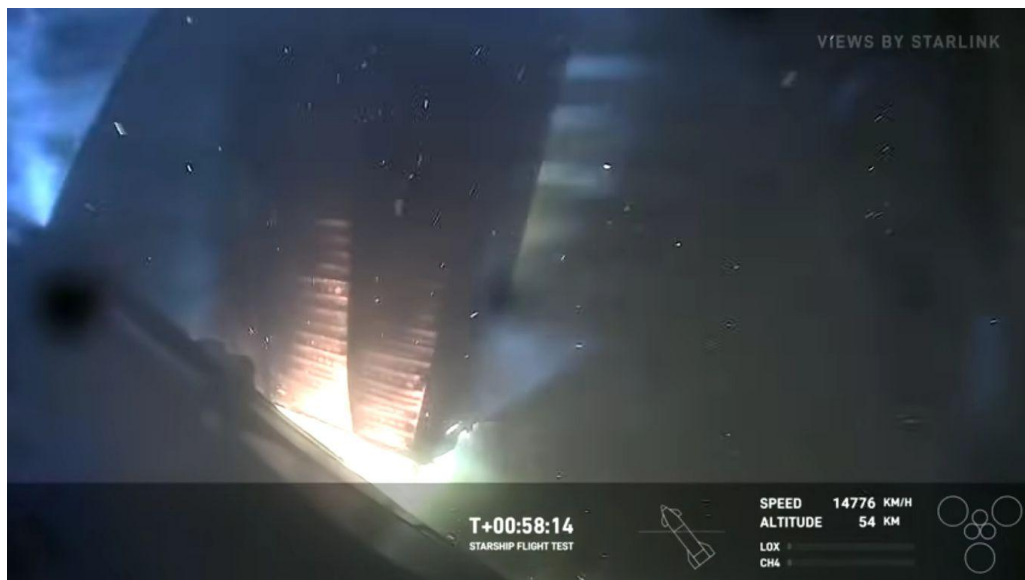
**Fig. 7 – Picture of hypersonic flow around the junction of hull with forward flap in the middle of braking**

Fig. 7 shows the same fragment of Ship surface after 9 minutes. Flight altitude is 54 km, speed is about 4.1 km/s, Mach number is about 13. The rear part of the flap in the place we are describing is already partially destroyed, and as the video shows [1] small pieces of material continued to fly off from it. In the end, it will fall off in this place, but fortunately at the moment when there was no longer any need for it [16]. It is unknown when the left flap fell off, since no TV camera was aimed at it, but most likely at about the same time.

Thus, it is absolutely clear that such geometry of the second stage is absolutely inadequate, and the vehicle with such forward tail will never fly normally. The developers of Hotel system gradually came to the same conclusions. Fig. 8 shows (looking from top to bottom) how during 1985 the forward horizontal flaps disappeared. It was replaced by extensions in front of the wing. The vertical tail remained in 1985, but due to the fact that it was in the aerodynamic shadow zone, it grew in size [17].
