Why did Starship second stage not explode in the ninth flight, but instead began to spin uncontrollably?

Yu. I. Lobanovsky

Summary

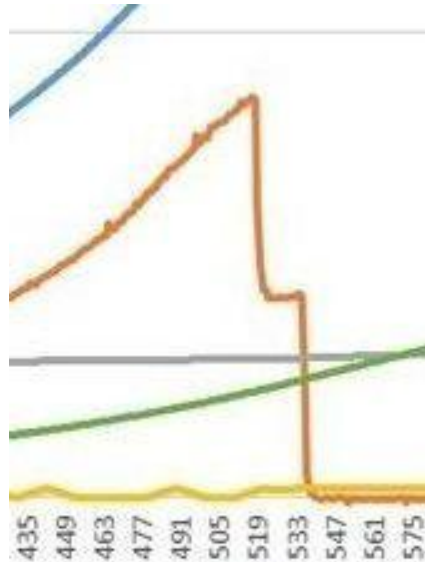
Due to change in form of data on altitude and flight speed presentation, as well as on amount of propellant in information window, in the video of the ninth flight, provided by SpaceX, the speed indications disappeared in trajectory phase of simultaneous flight of two stages [1]. Whether this is stupidity of interface "improvers", or consequences of the company's deliberate policy to reduce the amount of real information about flight for outside world, but now trajectory data available to us in the phase of second stage acceleration begins only from the seventh minute of the flight, see Fig. 1 [4].

Fig. 1 – Acceleration (brown line with step) of Starship on ninth flight (IFT-9)

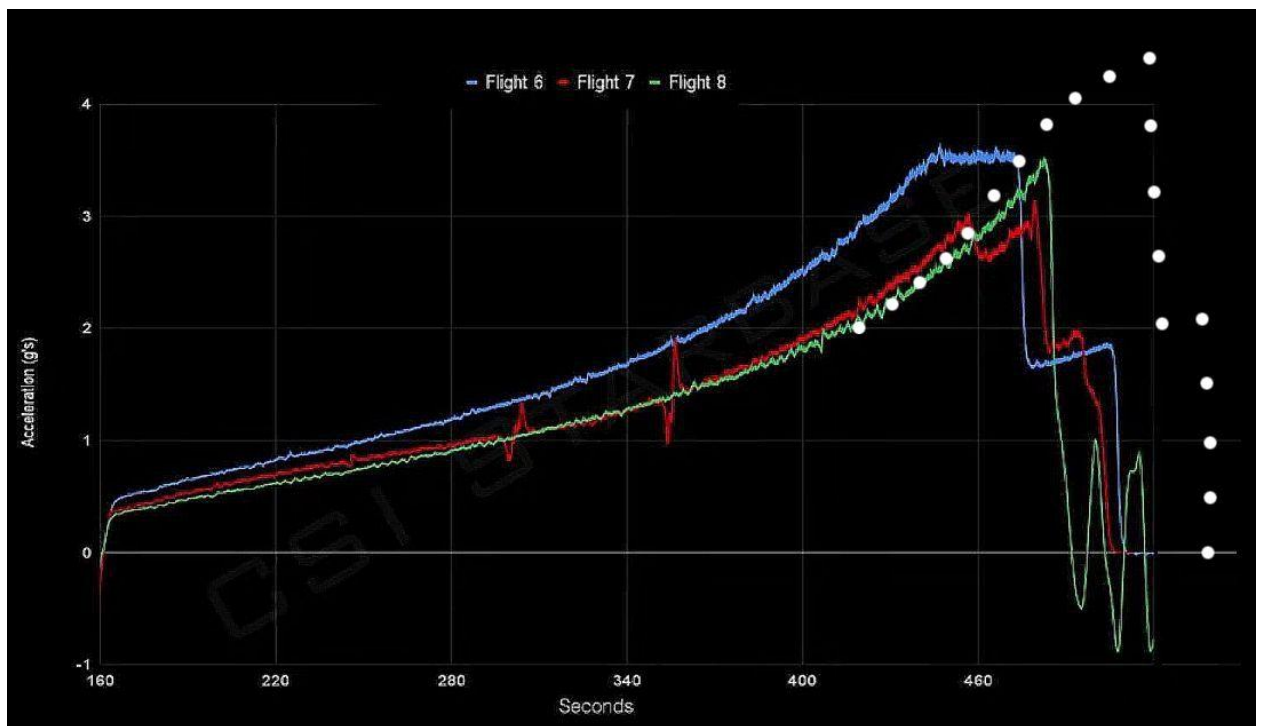
Fig. 2 – Accelerations of Starship second stage (lines) in sixth – eighth flights (IFT-6 – IFT-8), as well as its acceleration in the last, ninth flight (white dots)

The acceleration in boost phase of the second stage in the last, sixth flight of its V1 version is shown by the blue line, red curve refers to the seventh, and green one to the eighth flights (the first and second with V2 version of second stage). As in all launches, starting from the second (in the first, the stages weren't separated), after reaching an acceleration value of 35 m/s^2 , the engines were throttled so that the acceleration of the stage would remain constant, apparently for design dynamic loads on the vehicle wouldn't be exceeded. And this acceleration value was maximal along the entire flight trajectory of the second stage (for example, when it was braking in the atmosphere, the acceleration didn't exceed 17 m/s^2). At the same time, as shown in paper [7], the increase in the frequency of hydroacoustic oscillations in the lines supplying fuel components to the engines caused by throttling led to the excitation of auto-oscillations of Pogo type. It was they who caused the explosion of the second stage during the second launch of Starship. After that, during all flights of this second stage version, the side engines began to be switched off early, and a characteristic step appeared on the acceleration graph, clearly visible in Fig. 2 on the sixth flight.

During the first two flights of V2 second stage version, it never managed to exceed this mark, so we don't know how it should have accelerated after reaching this characteristic point. It is clear that own frequency of elastic longitudinal oscillations, which, together with hydroacoustic oscillations frequency, is responsible for Pogo occurrence, changed when transiting to new version of the stage. Without the ability to carry out the appropriate calculations, and in order to reliably avoid Pogo on the methane supply lines, as in the V1 version, SpaceX, as is known, radically redesigned pipelines for feeding it to the external engines of the V2 stage, resulting in the destruction of this structure by transverse oscillations on the seventh flight. At the same time (see red curve in Fig. 2), after the fires that started in the engine compartment, rocket engines began to shut down one after another, which ultimately led to the destruction of the stage as a whole and its combustion in the atmosphere [8]. The fact that the acceleration of new version second stage, all other things being equal, was significantly less than that of the old one, is explained by the fact that it had 300 tons, or 20 % more propellant. However, the lower average acceleration had to be compensated for by a longer acceleration time, what is evident from data of the ninth flight, see Fig. 2.

But by the 456th second of the flight, by the time of the first external engine failure in the seventh flight (according to the video [9]), one can already notice an increase in acceleration, and, respectively, engines thrust in the ninth flight compared to the eighth. And by the 503rd second, the moment of emergency shutdown of the first external engine in the eighth flight, the excess thrust is already at least 10 – 12 %. And then the thrust grows further, increasing acceleration, regardless of any structural limitations to $\sim 43 \text{ m/s}^2$, exceeding the previous maximum level by 20 – 25 % (see Fig. 2). Table 1 show the accelerations of all three V2 version second stages at the moments when they reach the maximal values of this parameter.

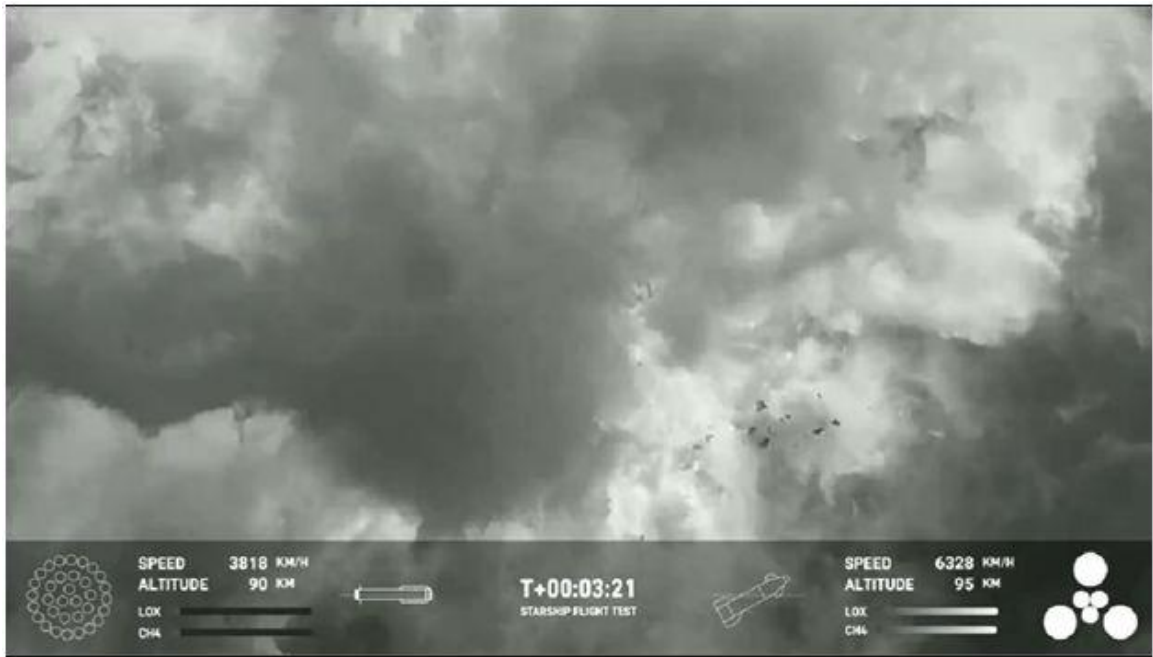
As is known, on November 18, 2023, during Starship second flight, at the first attempt to perform first stage return manoeuvre (boostback), it exploded, see Fig. 3 [10].

Fig. 3 – View of the sky one second after first stage explosion during second flight

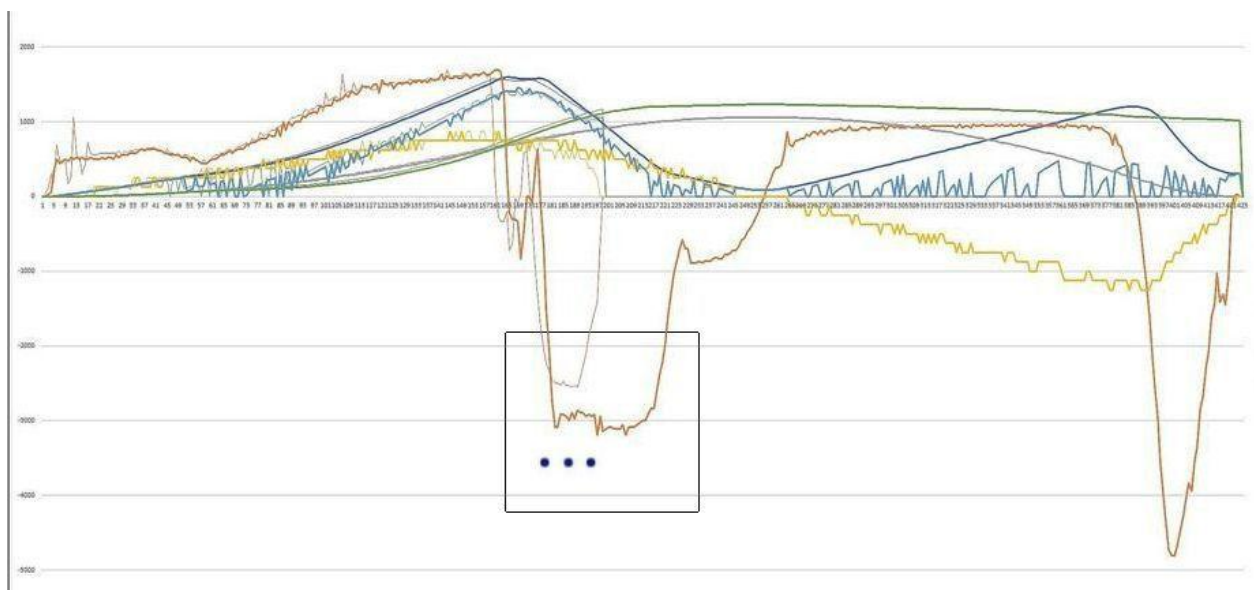
However, 4 months later, on March 14, 2024, during the third flight, boostback was completed relatively successfully – stage movement was able to turn, albeit in a slightly different direction than planned, and it exploded already when the engines were turned on at the final phase of braking [10]. That time, such a result was achieved due to active suppression of Pogo by throttling the engines during the boostback. Knowing the frequency of auto-oscillations at which the explosion occurred, and the parameters of the power plant at that moment, and also having by that time the formula for recalculating the frequency of hydroacoustic oscillations based on the pressure drop on pumps, derived by the author of this paper, using one of the methods available to SpaceX, the company's engineers reduced the thrust of the engines during this manoeuvre [11], see Fig. 4.

Comparing acceleration of first stages in the second – 25 m/s^2 (thin gray line) and the third – about 30 m/s^2 (thicker lilac line) flights on the quasi-stationary phase of boostback, highlighted by the rectangular frame in Fig. 4, taking into account that in the second flight only 9 engines out of 13 were working on this part of the trajectory, it is easy to find that in the third flight the thrust per engine was approximately 15 – 20 % lower than in the second. The calculated acceleration in the second flight with all engines working should have been about 36 m/s^2 . Its level is shown in Fig. 4 by three blue dots. It was this mode that unexpectedly for Starship's designers turned out to be inside Pogo excitation zone due to oscillations in oxygen supply system to the engines of first stage inner ring.

Fig. 4 – Acceleration, speed, altitude, and straight (horizontal) range, as well as horizontal and vertical components of Starship booster velocity during second and third flights [12]

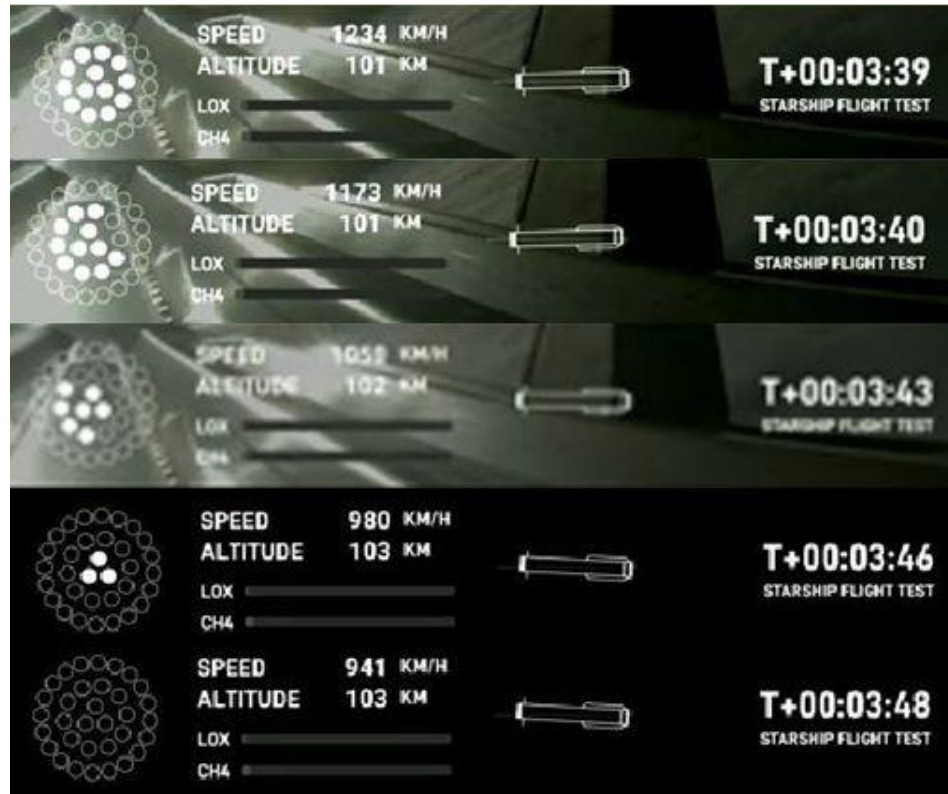
The indicated reduction in thrust, which in the third flight led to an acceleration during boostback of $\sim 30 \text{ m/s}^2$ during the operation of all 13 engines, didn't completely eliminate the excitation of auto-oscillations, since at the very end of the boostback they still reached such a level that the engines of the inner ring began to spontaneously and asymmetrically switch off [13], see Fig. 5.

Fig. 5 – Spontaneous shutdown of first stage inner ring engines at the end of boostback in the third flight

As can be seen from Fig. 5, the engines of first stage inner ring were switched off within approximately 7 s, starting from one side of the ring. Obviously, such a switching off order was caused by the asymmetrical arrangement of liquid oxygen mirror in the tank relative to its central axis. On one side of the tank, the layer of oxygen remaining there, under the action of the almost orthogonal inertia and gravity forces, was higher than on the other. Therefore, its hydrostatic pressure also differed, which led to comparatively small but significant differences in the pressure at the inlet to the engine pumps, and this, in turn, affected the pressure drop on the pumps. The higher the drop, the lower the frequency of hydroacoustic oscillations, the sooner the frequency of elastic oscillations can approach this frequency, and the sooner the fuel system of a given engine will begin to generate auto-oscillations, leading to its switching off.

Therefore, the engine or, more precisely, their near couple, see Fig. 5 at T+00:03:40, with minimum oxygen layer thickness above the pipeline inlets, was the first to shut down. And then, as the oxygen was consumed, the shutdown front began to move along the ring together with a decrease in oxygen level symmetrically relative to the axis passing through minimum and maximum points of this level in the tank, until all the engines of this inner ring were successively shut down. Thus, the upper engines of the ring were the first to shut down, which led to the "upward dive of the stage" noticeable even in Fig. 5 and a steeper return trajectory. Having worked for 2 – 3 s after the shutdown of the last engines of the inner ring, 3 central swinging engines were able to prevent uncontrolled rotation of the booster, however, they were no longer able to completely bring the magnitude and direction of the velocity vector after the cut-off to the specified value, and the booster attempted to splash down with an explosion at off-settlement point, further from coastline than planned [11].

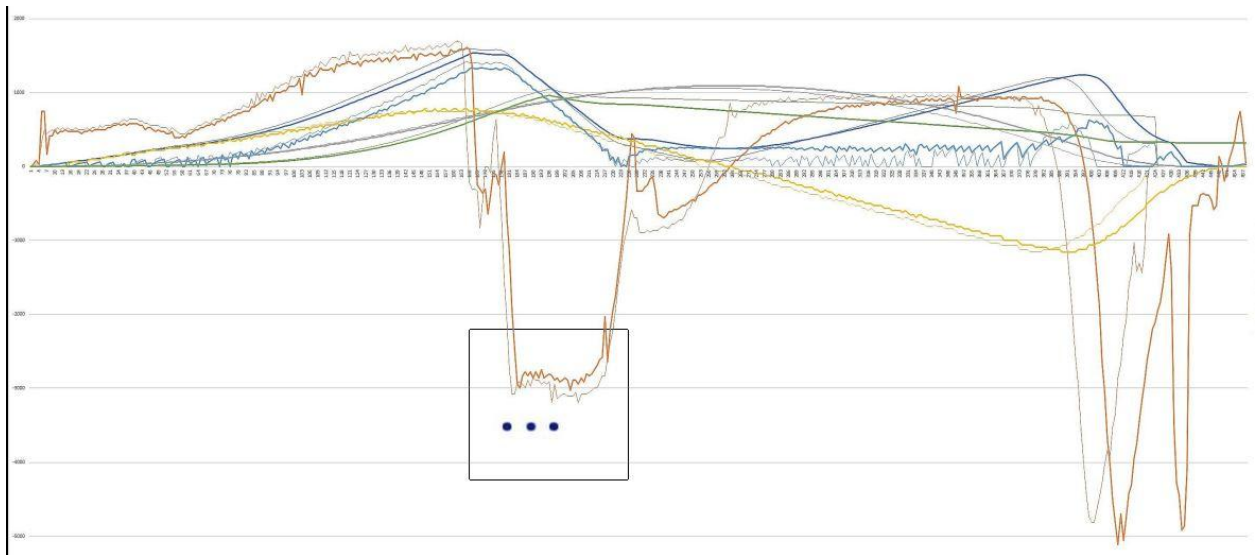
With the improved data, SpaceX was finally able to completely eliminate the impact of boostback oscillations on Starship first stage flight on June 6, 2024, during the fourth flight. Figure 6 shows a comparison of flight parameters for the third and fourth launches [14].

Fig. 6 – Acceleration, speed, altitude, and straight (horizontal) range, as well as horizontal and vertical components of Starship booster velocity in the third and fourth flights

Although the differences between the thrust levels in these two flights in quasi-stationary boostback modes are minimal (see the area in Fig. 6 highlighted by the rectangle), the consequences of this change in the rocket engines operating algorithm turned out to be quite significant.

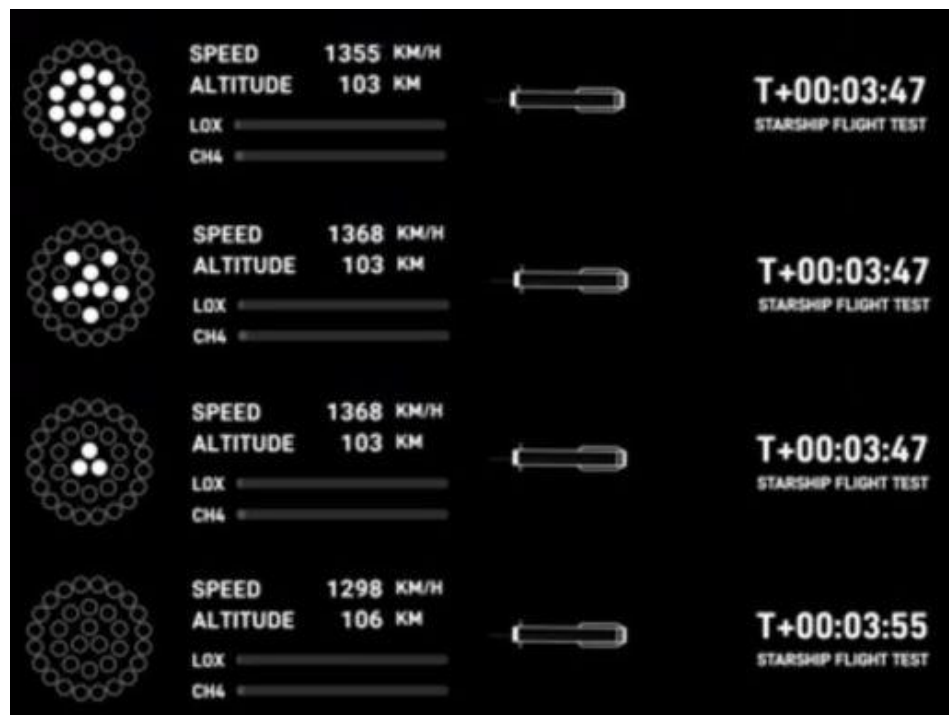
It turned out that it was enough to reduce the maximum thrust of the engines by approximately 3 % more, bringing the maximum (by module) acceleration during boostback to $\sim 29 \text{ m/s}^2$, to completely suppress Pogo and ensure ideal axisymmetric program shutdown of the inner ring engines, see Fig. 7 [15]. Initially, first 5 engines of the ring were switched off simultaneously, every other one, and then the remaining 5. After 8 s, 3 central engines were also switched off simultaneously. And then, the booster made a planned flight and smoothly splashed down at the planned point in the Gulf of Mexico. True, it then exploded, but this was a natural development of events associated with its horizontal position on the surface of the water. The next booster, picked up by the launch and landing complex after fifth flight, remained practically intact.

Fig. 7 – Planned axisymmetric shutdown of the first stage inner ring engines upon completion of the boostback in the fourth flight

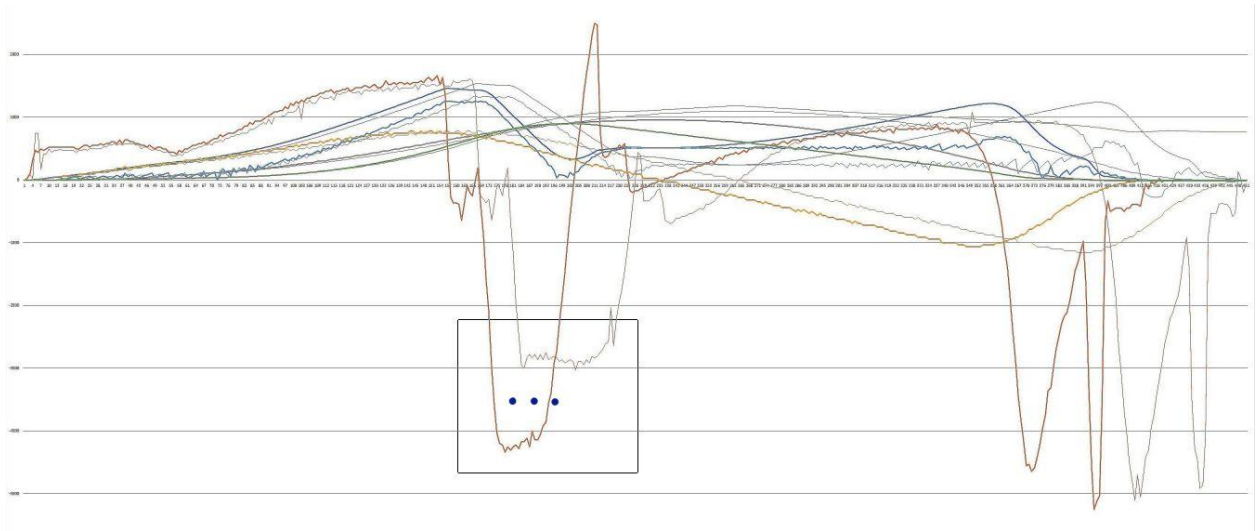
in losses of the characteristic velocity. Therefore, in the fifth flight on October 13, 2023, when the first stage was first picked up by the launch and landing complex, the maximum acceleration and, consequently, the engine thrust increased during boostback by about 1.5 times (acceleration – from 29 to 43 m/s²), see Fig. 8. At the same time, the entire flight of the first stage was completely successful and faster than before. Pogo process didn't occur because the frequency zone where it could exist was quickly passed, and it didn't have time to fully evolve where it would have been possible in the quasi-stationary flight mode.

Fig. 8 – Acceleration, speed, altitude, and straight (horizontal) range, as well as horizontal and vertical components of Starship booster velocity on the fourth and fifth flights [16]

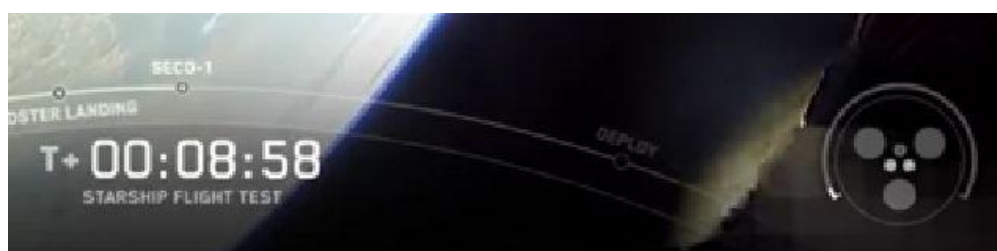
After the ninth flight, when the maximum thrust of Raptor-2 engines of the second stage was increased, which made it possible to ensure the operation of their version with a vacuum nozzle, at least until the time of ~ 520 s from the launch, at the cost of increasing maximum overload of the stage by 20 – 25 % compared to all previous flights, for the first time there was a non-simultaneous shutdown of three central engines of the stage, see Fig. 9 [1].

Fig. 9 – Non-simultaneous shutdown of three central engines of the second stage during the ninth flight

The most probable, if not to say obvious, systemic explanation (if we don't consider random failures of some elements of one of these engines) is the excitation of auto-oscillations on one of the three such engines. Qualitatively, the description of this process is completely analogous to the spontaneous shutdown of those inner ring engines from first stage in the third flight during a boostback due to Pogo. And the quantitative differences are

explained by the rather large distance from each other of those ten inner ring engines and the proximity of these three central engines. Further explanations of this phenomenon are hardly required.

As a result of the premature shutdown of at least one of the three central engines, a moment of force was created, due to which the stage began to rotate uncontrollably. As follows from the subsequent frames of this flight video, with the help of the gas rudders it was possible to almost completely stop this rotation, but in doing so the boost gas was spent, and further control of the stage's orientation was lost [1].

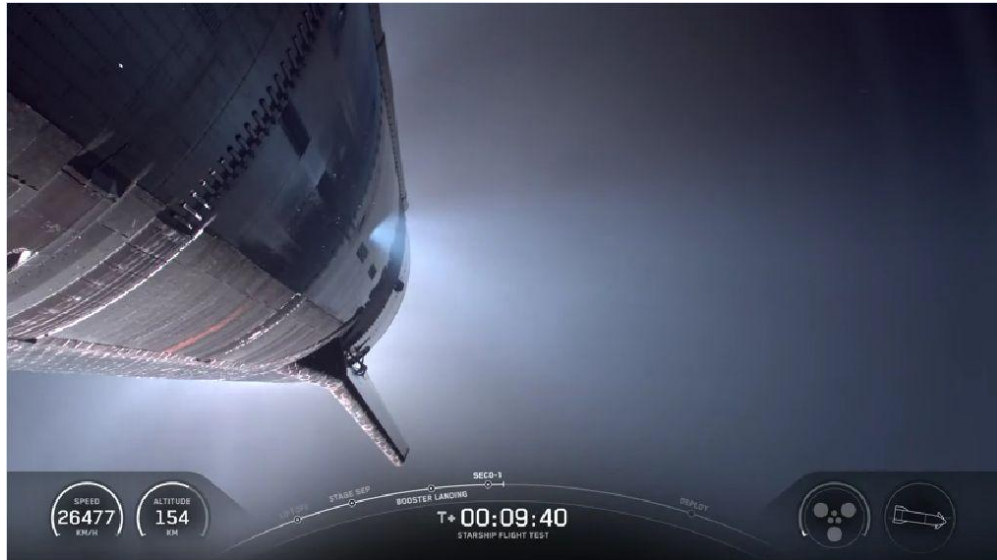
Fig. 10 – Gas leakage through the side wall of Starship second stage after its engines are cut off

In addition, the maximal stage overload at the end of the acceleration of about 4.3 – 4.4 instead of ~ 3.5 units in all previous flights could have led to failures and/or destruction of some structural elements of the second stage. At least for 40 seconds from 9:30 to 10:10, it was possible to observe the outflow of blue gas (most likely, boost gas, consisting almost entirely of oxygen) through the side wall of the stage (no valves were provided there), see Fig. 10 [1].

This gas emission, apparently through a crack in the wall, on the one hand increased the stage's spin, and on the other hand reduced the reserves of boost gas for controlling its orientation. As a result, as in the third flight, the second stage entered the atmosphere in an unplanned manner and was destroyed, for the third time in a row not allowing for an experimental assessment and analysis of innovations related to improving its aerodynamic configuration and thermal protection, which SpaceX began working on immediately after the completion of the fourth flight, which was already a year ago [17, 18]. But all this might not have happened if SpaceX had used the equations for calculating the frequency of hydroacoustic oscillations to predict the conditions for the occurrence of Pogo when changing the design of Starship, and not had applied only the consequences of their decisions only after accidents had already occurred.
