# Analysis of Landing Failures of Starship V3 booster

Yu. I. Lobanovsky

### III. Analysis of the First Two Failed Landing Attempts of V3 booster

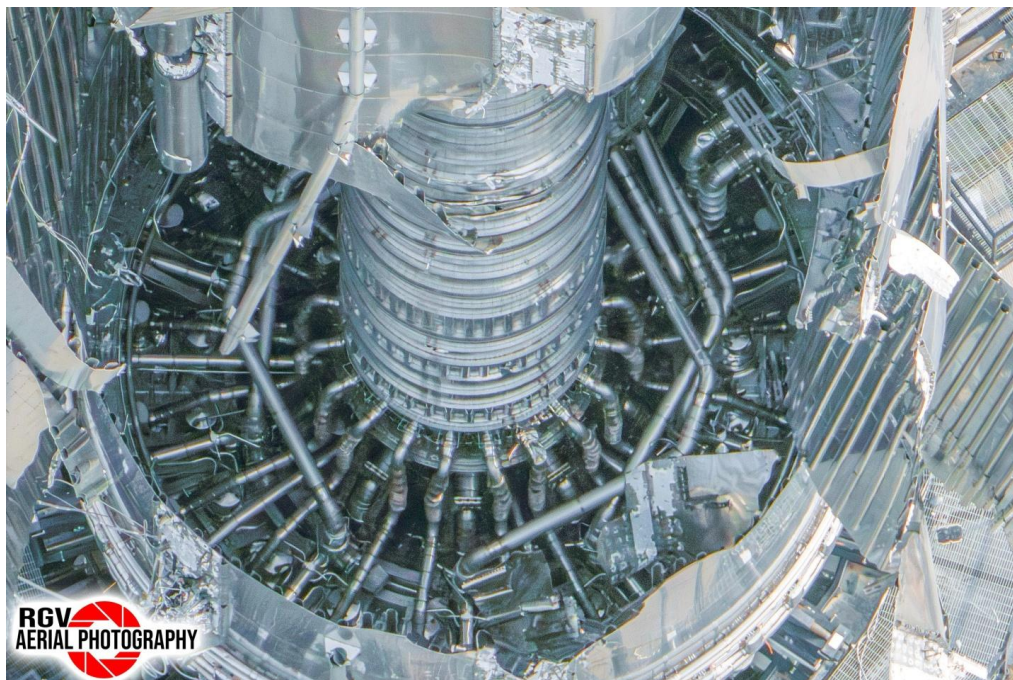
**Fig. 1 – Visible section of the feed lines running from the side oxygen landing header tank to the engines of B18 booster [6]**

- "The unprecedented transverse size of central methane pipeline led to the displacement of previously existing oxygen header tank in the center of main tank to its side wall, resulting in pipelines with at least 7 different lengths that will supply oxygen to the engines during the booster landing.
- This, in turn, means that opportunities arise for the emergence of up to 7 new variants of Pogo-type auto-oscillations, which can lead to a booster disaster during landing.

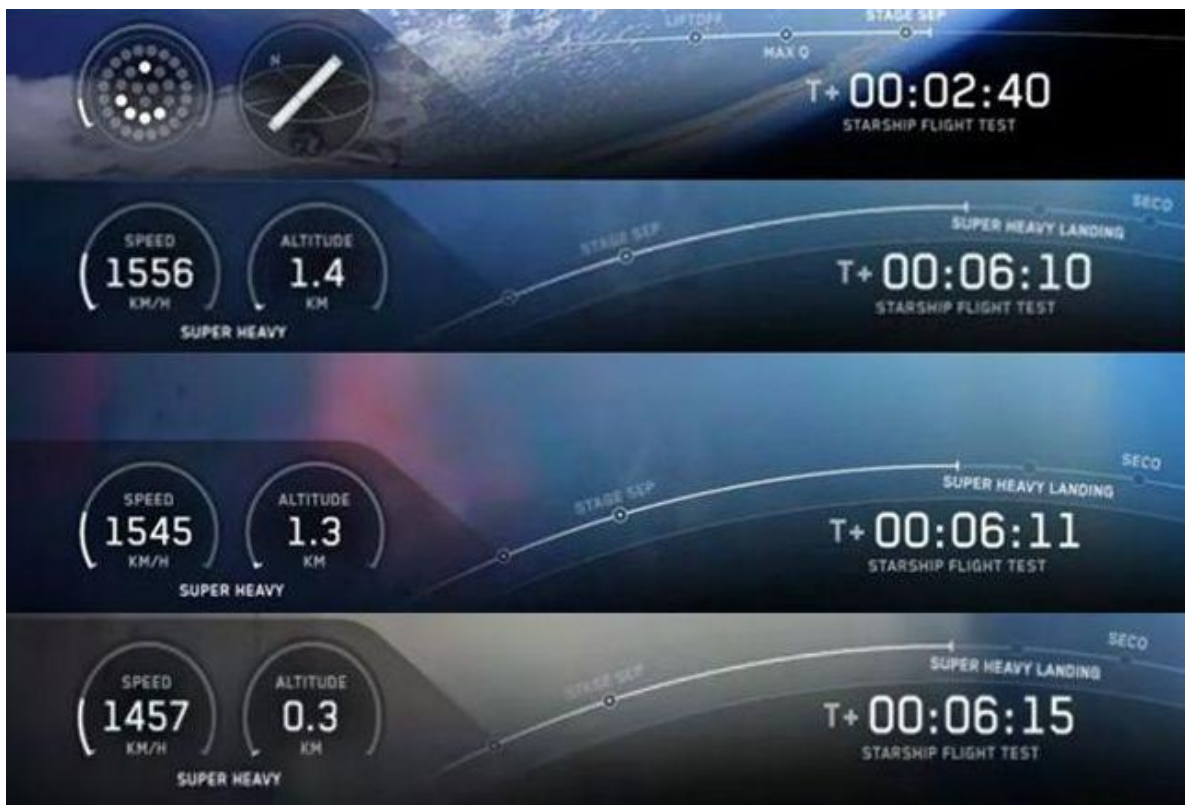
**Fig. 2 – Trajectory and other telemetry data during the boostback burn and landing burn attempts of B19 booster [13]**

Fig. 2 illustrates which 5 engines operated during the boostback burn attempt of B19 booster (at timestamp 2:40), as well as its velocity and altitude values at the inception of the landing burn attempt (at the 6:10 – 6:11 mark) and just prior to water impact and subsequent destruction (at timestamp 6:15). As follows from further consideration, the engines that tried to turn on (if there were more than one) not only failed to increase the deceleration force acting on the booster but actually significantly reduced its aerodynamic drag. Most likely, an

ignition attempt occurred for only one or a very small number of the five engines seen operating in the upper section of Fig. 2. All of these were inner ring engines, which lack thrust vector control capabilities.

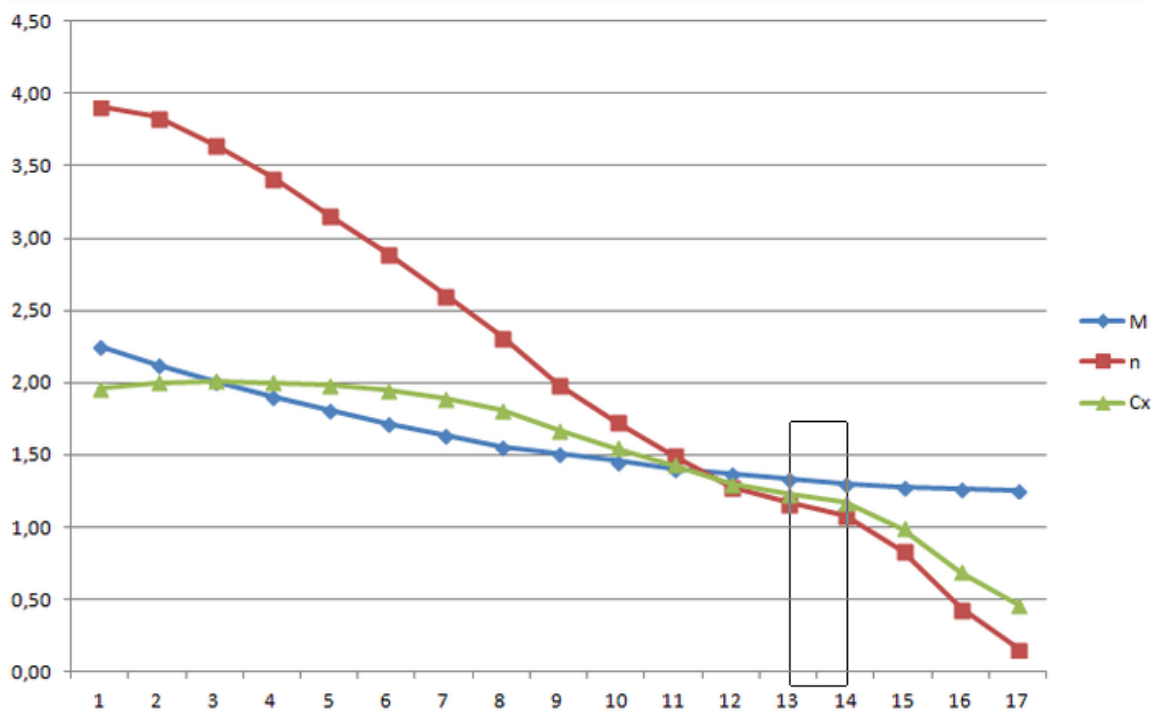
**Fig. 3 – Estimations of Mach number  $M$ , longitudinal load factor  $n$ , and axial force coefficient  $C_x$  for B19 booster during the terminal trajectory phase prior to water impact**

What is significantly more interesting is that following the onset of engine/engines operation (a moment highlighted by the rectangle in the graphs of Fig. 3), the axial force coefficient not only failed to increase due to the addition of a thrust force directed opposite to the velocity vector, but, on the contrary, decreased sharply. But after all, the full thrust of a single Raptor 3 engine at that altitude should have been approximately 2.5 MN. For a booster's mass of  $\sim 210$  metric tons, this would have added an increment of  $\Delta n_e \approx 1.2$  to the aerodynamic drag-induced load factor, and even at a throttle thrust down to 40 % from nominal, the increment would be  $\Delta n_e \approx 0.5$ . Instead, the load factor dropped nearly to zero, and the axial force coefficient, which stood at  $C_x \approx 1.25$  prior to engine ignition (but after the commencement of gas venting from the nozzles during startup sequences), plummeted to  $C_x < 0.5$ , approaching the values of a sharp-nosed cylinder (see Fig. 4). The total axial force became virtually equal to the booster's weight, and for the final 4 seconds of flight (6:11 – 6:15), from an altitude of about 1 km, the vehicle descended at an almost constant velocity despite some level of engine operation. More precisely, the booster fell in this manner because of this engine operation, since under "pure aerodynamics" it would have decelerated more intensively.

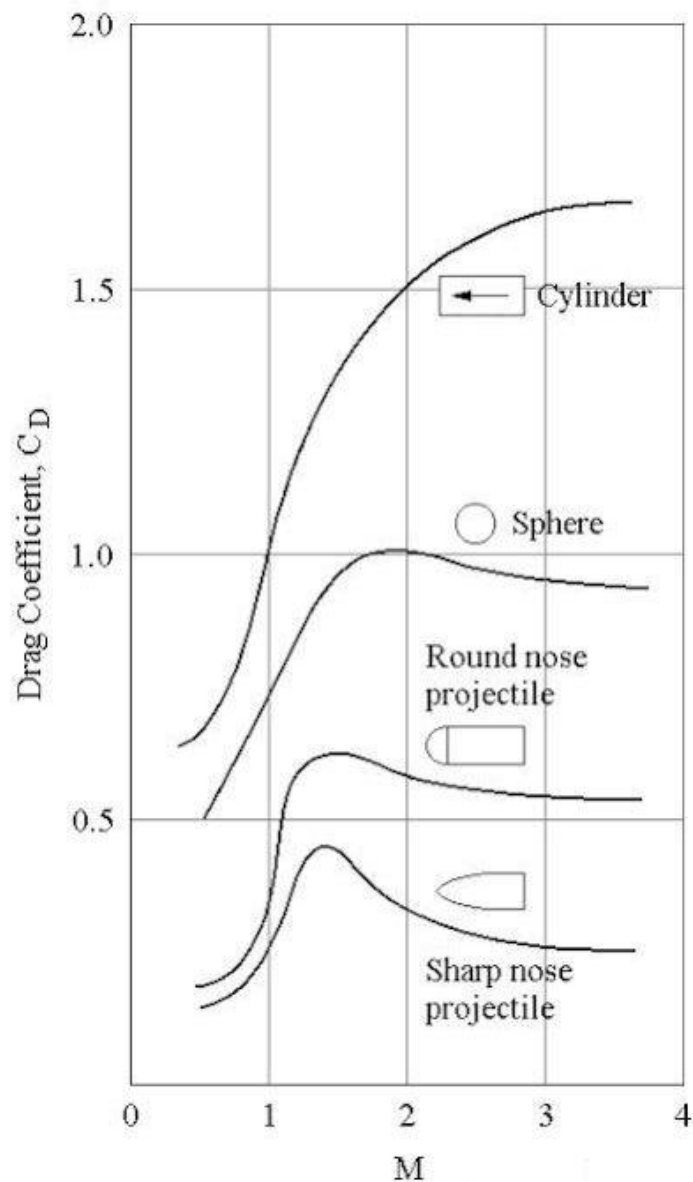
**Fig. 4 – Drag coefficients of selected axisymmetric bodies [14]**

The explanation for this paradox is fairly simple: it is well known from both physical experiments and numerical simulations that when a counterflowing gas jet is discharged from a nose cavity against an oncoming freestream at  $M \approx 1.3$ , the aerodynamic drag of the body can decrease by up to 35 %. In the case under consideration, the situation is more complex due to the existence of at least 33 "cavities" and the asymmetry of thrust; this is likely why the reduction in the booster's aerodynamic drag proved to be even more pronounced. Ultimately, one point remains qualitatively clear: prior to touchdown, too few engines (apparently only one) ignited on B19 booster, and none of them reached even the minimum throttle capability. The jet that reduced the aerodynamic drag persisted for 4 to 5 seconds, whereas any discernible thrust failed to materialize entirely. Therefore, based on the data presented in Figures 2 – 4, it can be asserted that not a single engine on B19 booster started normally during the landing sequence.

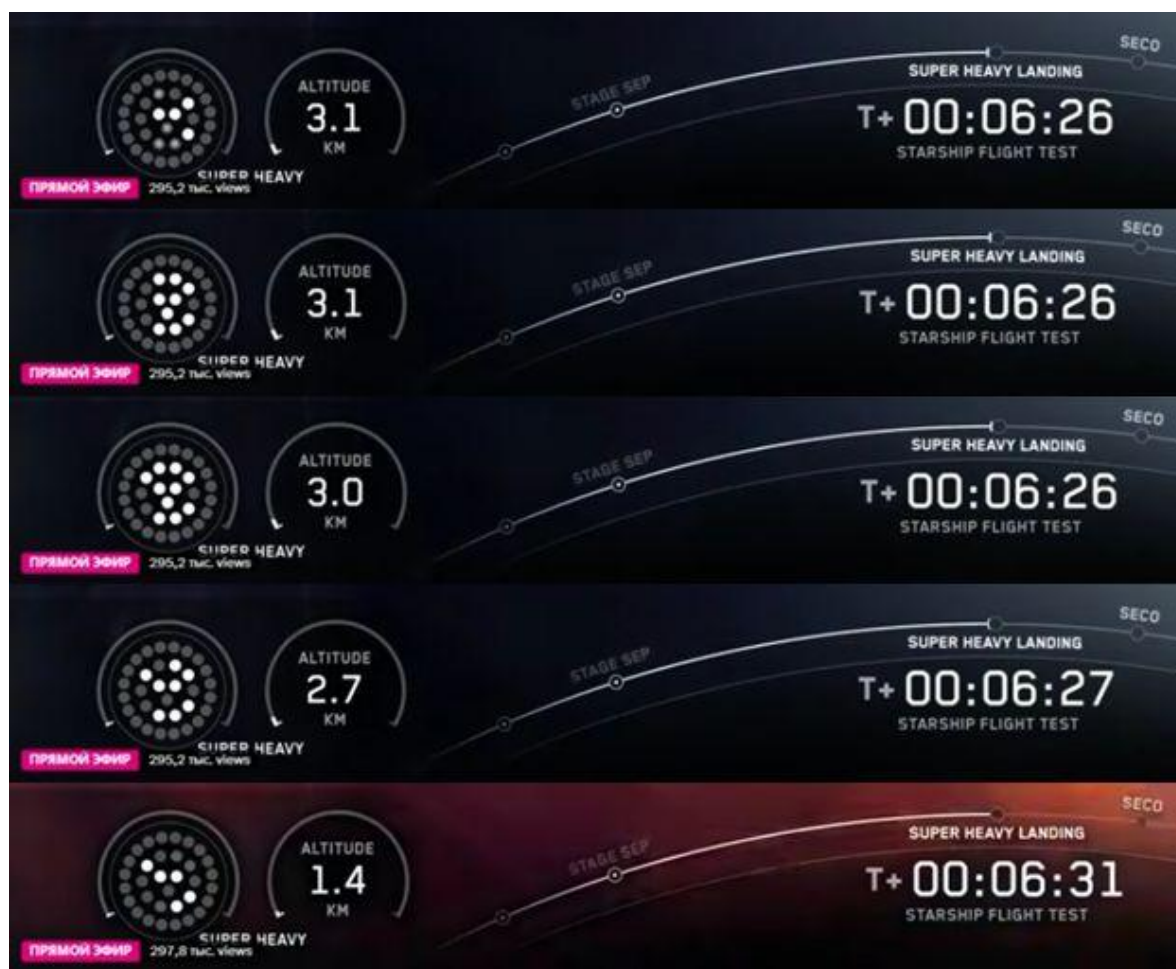
Let us now examine the ocean splashdown attempt of B20 booster. Figure 5 illustrates the sequence in which the engines ignited and shut down during this phase. Ultimately, only 5 engines operated instead of the intended 13, preventing the booster from decelerating sufficiently and leading to its destruction upon water impact, albeit at a lower velocity. Unfortunately, no public trajectory data is available for this specific flight segment. However, extrapolation of the velocity from an altitude of 7.4 km down to 1.4 km – the engine ignition altitude – indicated that the velocity at that moment was between 325 and 330 m/s. This aligns precisely with the velocity data of all prior successful landings executed by the preceding booster version. Thus, it can be inferred that following almost completely successful boostback burn (which concluded with a minor shutdown timing discrepancy among the three center engines, causing a slight deviation from the target landing point), the trajectory parameters of B20 booster at the moment of landing burn ignition were virtually nominal, unlike those of B19 booster.

Однако, запуск 13 посадочных двигателей, судя по иконографии, продолжался 4 – 5 с, на However, judging by the telemetry graphics, the ignition of the 13 landing engines lasted for 4 – 5 seconds; while 10 out of the 13 engines responded to the control signals, only 5 ultimately ignited (see Fig. 5). Consequently, three pairs of deactivated, opposing inner ring engines were formed: E4 – E9, E5 – E10, and E6 – E11 (the engine numbering is provided in reference [15]). These engine triplets (E4 – E6 and E9 – E11) are located sequentially along the inner ring, with the first engine of each pair starting from the upper right of the inner ring, followed by clockwise counting, as shown in the lower inset of Fig. 5. The remaining two engines that failed to start – the central engine E2 and the upper left inner ring engine E13 – "flickered" for several video frames but eventually "went out." Overall, qualitatively, this pattern aligns with the author's prediction made immediately after the internal structures of the B18 booster became visible following its destruction during ground testing in November 2025: "...this [increasing the cross-section of the booster methane pipeline] led to the displacement of the landing oxygen header tank to the side wall of the main tank, and to the appearance of a whole bundle of pipes of different lengths for supplying oxygen to the engines. This can quite reasonably be seen as setting the scene for a highly probable appearance of a small orchestra (a kind of sextet, consisting of a central performer and 6 pairs of side that of), performing hydroacoustic melodies at 7 different frequencies during landing. So, while some SpaceX engineers, sweating profusely, are studying accidents and changing engine operating modes to suppress the identified Pogo variants, others are just as diligently creating conditions for even more of them to arise. What the company's management is doing in the meantime is difficult to say" [5].

**Fig. 5 – Activation and shutdown of B20 booster engines during its landing attempt [16]**
