Second crisis of Starship program

Yu. I. Lobanovsky

This paper shows that failures of Starship second stage – Ship Block 2 in the last two flights occurred for two different reasons. In the seventh flight, this happened due to the occurrence of transverse fluctuations of new design pipelines for feeding methane to the external engines with vacuum nozzles, and in the eighth – due to the occurrence of longitudinal auto-oscillations of Pogo-type with hydroacoustic fluctuations in the oxygen feeding lines.

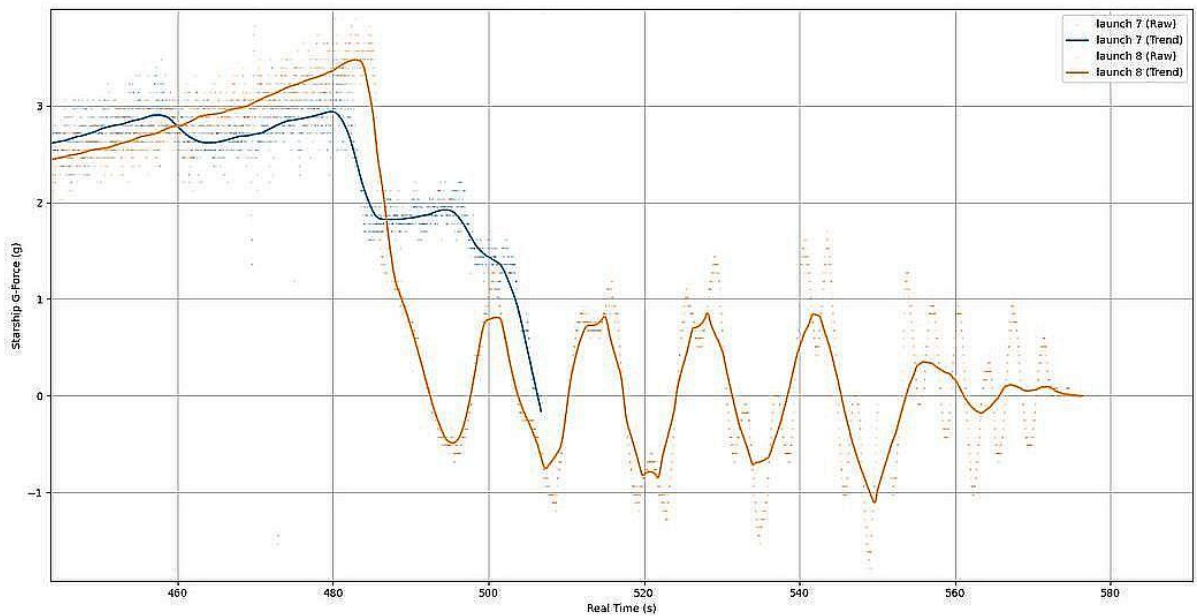
Fig. 3 – Accelerations of the second stages (Ships) during the final sections of the last two flights (IFT-7 and IFT-8)

Fig. 3 shows in more detail the accelerations (also in fractions of g) in the final sections of the second stage acceleration in the seventh and eighth flights, which are key for understanding what happened [7]. Field of points received from the frames of the speed readings in video [9] after smoothing the data was displayed in the form of two relatively smooth curves presented here.

At the same time, from the data presented in Fig. 3, it can be concluded that the fluctuations in acceleration, and therefore thrust, began quite a long time before the first engine was turned off. The amount of methane in the tank from the time of approximately 8:04 began to decrease significantly faster than oxygen, so that only 16 seconds later, by 8:20 – the last time mark when the background in the frame allowed us to more or less accurately track the readings of the fuel indicators, the residual proportion of methane in the fuel tank was no more than 60 % of what was in the oxidizer tank, see Fig. 7. And the moment of 8:04 is very close to the moment of failure of the first external engine with a vacuum nozzle, if they don't coincide at all, although the fires in the tail section (in the attic) had been going on for a little more than three minutes by this time.

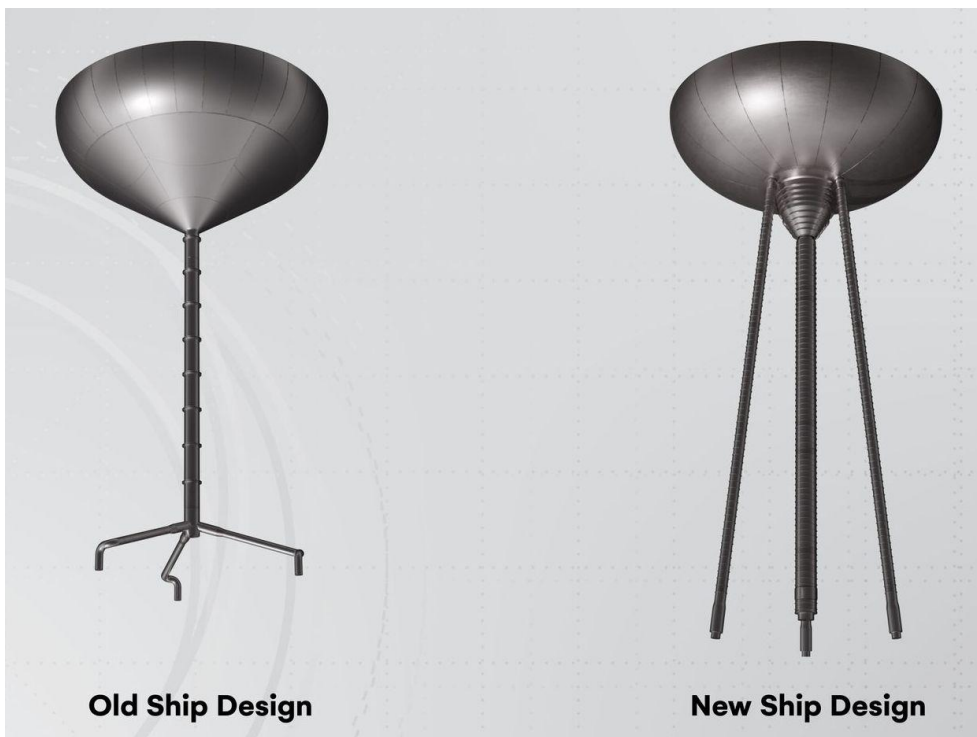
Fig. 4 – Architecture of methane feedlines of Ship's first and second versions

And then it turned out that the methane supply to all six engines was carried out with the help of one pipe running along the central axis of the oxygen tank, and already at the very end of this single pipe there were 3 side branches to the engines with vacuum nozzles, and just below there were 3 branches to the central engines with short atmospheric nozzles, see the left image in Fig. 4 [12]. And this, as the author was well aware from the experience of assessing hydroacoustic frequencies in penstocks of hydroelectric power plants, radically changed the whole matter.

A simple conclusion follows from this that the frequency of hydroacoustic oscillations of methane feedlines of the second stage outer engines was in no way related to the distance of methane tank from them and it was much higher than obtained in the first calculations, which assumed the use of a feed system without branches. And then it became known [15] that in the second version of Ship Block 2, SpaceX actually switched to exactly this scheme with direct feeding of Raptor-2 outer engines using separate methane pipelines, see the right part of Fig. 4 (the third pipeline isn't visible because of the remaining, as before, thick central pipe, through which methane is supplied to 3 central engines with atmospheric nozzles). Obviously, in such a configuration, outer engines couldn't excite Pogo, unlike with Ship Block 1 situation. The branches of the methane pipelines to the central engines were even shorter, and frequency of their hydroacoustic oscillations was even higher than that of outer engines, which also took them out of Pogo zone.

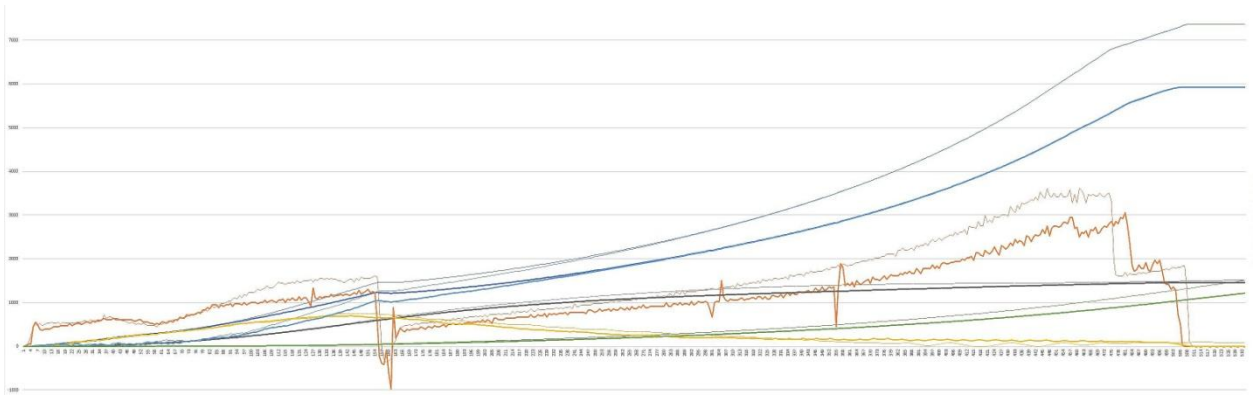
Fig. 6 – IFT-6 and IFT-7 flights (second stages), accelerations – thin and thick purple lines at IFT-6 and IFT-7 respectively, with sharp steps [17]

"Roughly two minutes later [more like 65 seconds, or 6:03 – 6:04, see Fig. 6], another flash was observed followed by sustained fires in the attic. These eventually caused all but one of Starship's engines to execute controlled shut down sequences and ultimately led to a loss of communication with the ship. Telemetry from the vehicle was last received just over eight minutes and 20 seconds into flight.

In order to correctly translate the last two paragraphs of the report quoted above from the specific corporate language into English, let us again refer to Figs. 2 and 3, as well as to description of the second-stage engine failures. At 7:40 (460 s after start and 95 s after the second flare), the central engine performed first "controlled shut down", at 8:02 this happened with the second central engine, and at 8:04 – with the neighbouring outer engine. At 8:18, Ship lost the second outer engine, at 8:23 the last of the three central engines failed, and at 8:26, at an altitude of 146 km, contact with the vehicle was lost [18] – 27 seconds before the planned engine shutdown [19]. It remains unknown when the last outer engine stopped working. Thus, the engine shutdowns lasted no less than 46 seconds.

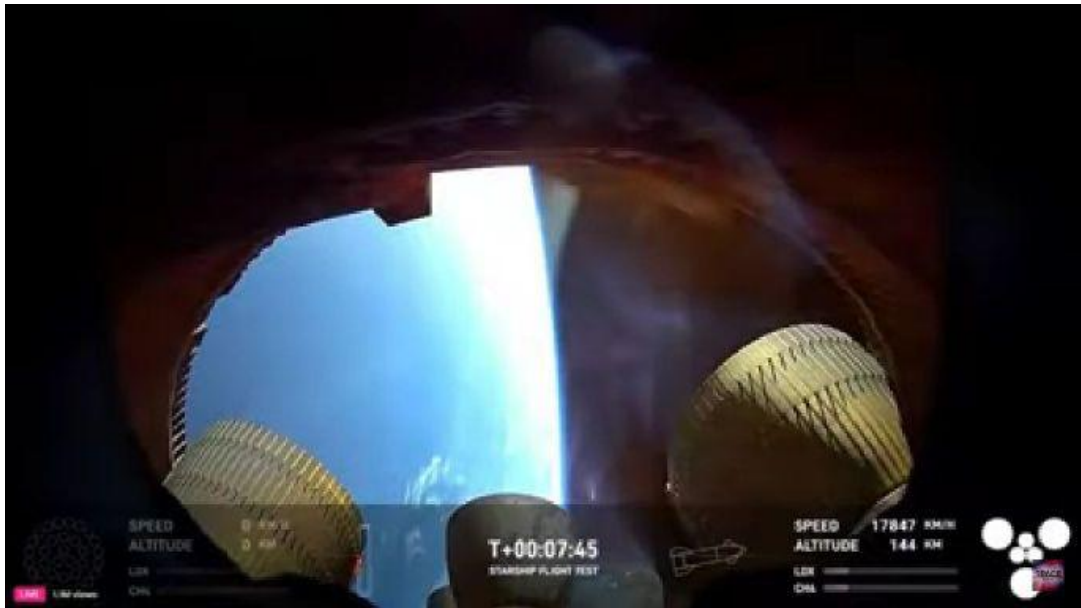
Fig. 8 – Reflection on the edge of the ship's attic a short flash of flame in its upper part during IFT-8

In the eighth flight, despite the fact that the precursors of the impending accident also existed, the first of them could be noticed only about 20 seconds before the accident – at 7:45, a weak reflection of a short flash of flame appeared in the attic somewhere in the vicinity of the rear cover of the oxygen tank [23], see Fig. 8. Thus, the time of the emergency process development at IFT-8 was an order of magnitude shorter than at IFT-7, and corresponds well to the typical times of development of auto-oscillations of Pogo type.

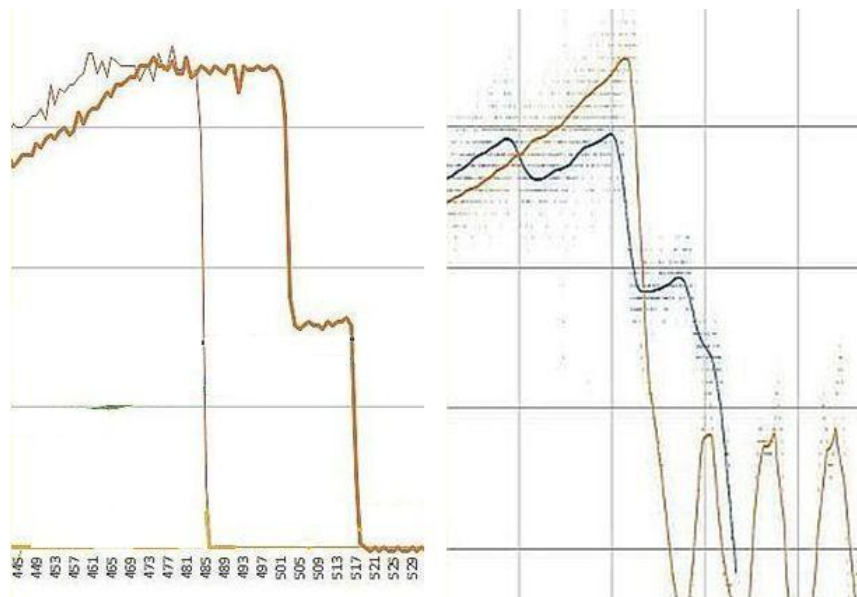
Fig. 9 – Accelerations of Ships at IFT-2, IFT-3, IFT-7 and IFT-8 shortly before the engines stopped working

Now let us return to the consideration of the trajectory data. Fig. 3 shows quite well the process of successive shutdown of Ship S33 engines by the control system in the seventh flight. The chronology of this process is given in the previous section of this work. At the same time, in the eighth flight, at 8:04, the outer engine (with the vacuum nozzle) exploded and stopped working, and, judging by the iconography, in 2 – 3 seconds, and most likely even faster, all three central engines stopped working. The two remaining outer engines, located further from the explosion and protected from it by the central engines, nevertheless continued their work, forcing the ship to perform impressive somersaults, reminiscent of Starship first flight. The answer to the question of why they didn't explode will be given below in this text.

It should be noted that, with the exception of this moment, the development of the second stage failure at IFT-8 is very similar to what happened 15.5 months ago at IFT-2, see Fig. 9, the left part of which shows the accelerations of Ships before the failure at IFT-2 and before the completion of the boost at IFT-3, and the right part shows similar accelerations at IFT-7 and IFT-8 before new failures. The graphs are reduced to the same scale, different smoothing criteria lead to different smoothness of the compared curves. The similarity of the failures in the second and eighth flights is undoubtedly, as is their difference from the failure in the seventh flight.

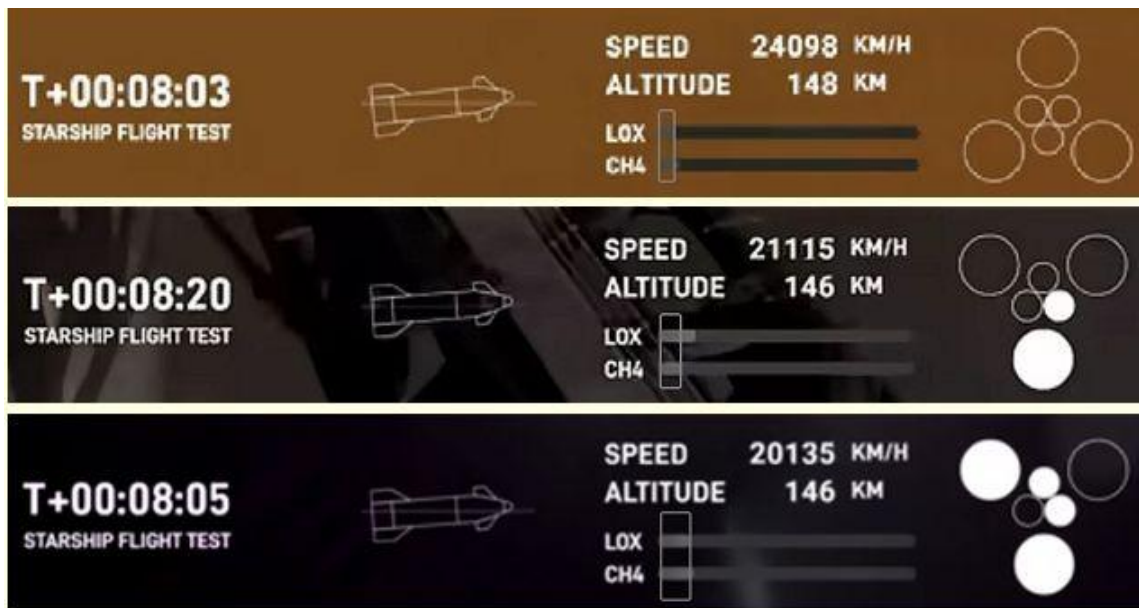
Fig. 10 – Oxygen and methane ratios in the tanks of Ships at IFT-2, IFT-7 and IFT-8 at the culmination moments of the three accidents

During the normal course of the process, the proportions of the remaining fuel in the rocket stage tanks should be approximately the same, which is usually the case. When watching the videos of all eight flights of Starship, you can sometimes see some deviations from the equality of the proportions of methane and oxygen, especially at the moments of accidents. Even in Fig. 10, you can see that in the second flight, at the moment of engine shutdown, the proportion of oxygen was slightly less than the proportion of methane (see the upper window of Fig. 10), and in the eighth flight, it became slightly larger than the proportion of methane (see the lower window). This could be due to the inaccuracy of the fuel level sensors, as well as leaks of its components – without this, the fires in the attic, apparently, wouldn't have been possible. However, all these leaks are so small that they are quite difficult to see on the corresponding indicators. But in the seventh flight (see the middle window) the difference in the shares of the components, which arose in just ~ 15 seconds, is very large, despite the fact that by the beginning of this phenomenon, half of the engines had already turned off, and the fuel consumption had decreased at least twice compared to the nominal. It is worth noting that in the eighth flight at 8:20 the sensors showed more liquid in the oxygen tank than in the seventh flight 15 seconds before. It is quite obvious that with transverse vibrations of long and thin pipelines, their destruction begins at the place where their ends are fixed, therefore, it can be expected that methane from a damaged or even destroyed pipeline began to get into the oxygen tank, as a result of which an unprecedented disproportion in the fuel components arose at that moment.

There was nothing like this in either the second or the eighth flights. Initially, the author, who didn't have a scheme of the methane pipelines in the second stage at that time, assumed that the length of the oscillatory circuit from the methane tank to the engine pump also included the height of the oxygen tank. In this case, no auto-oscillations of Pogo type with oscillations in the methane feeding lines could be excited. And Pogo process with oscillations in the oxygen circuit was possible in principle. Therefore, the explosion of the second stage in the second flight was explained by this process [11].
