# Mechanism of Starship first stage explosion during its return maneuver

Yu. I. Lobanovsky

## Summary

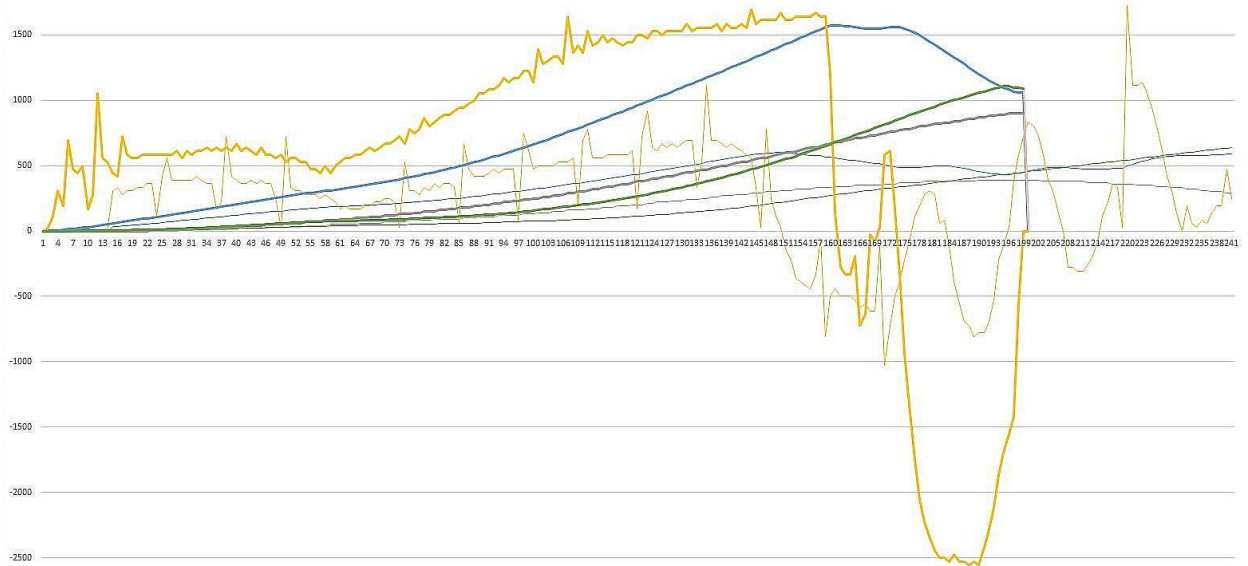
**Fig. 1 – Acceleration, speed, altitude and range of Starship in the first and second flights [4]**

In Fig. a comparison was made (see [4], where a comparison was made over time (in seconds) of four Starship parameters in two flights, namely: rocket acceleration (in cm/s<sup>2</sup>), speed (in m/s), altitude (in hm), as well as direct (horizontal) flight range (also in hm). Data related to the second flight (IFT-2) is displayed with thick lines, and data related to the first flight (IFT-1) is displayed with thin lines. Acceleration is shown with yellow curves, speed with blue lines, altitude with olive lines, and range with purple lines.

During the first 55 – 60 seconds, the acceleration of Starship varied slightly in the range of 5 – 6 m/s<sup>2</sup>, and then for 100 seconds it slowly increased to approximately 16 m/s<sup>2</sup>, (see Fig. 1) [4, 5]. Acceleration components, associated with slow changes in the position of rocket hull in space relative to its center of mass, were very small even in absolute value. So, with the characteristic period of Starship hull own oscillations at IFT-2 being about 0.1 seconds, the quasi-stationary approach to Pogo calculations was completely justified. However, at the initial stage of the return maneuver, changes in dynamic characteristics occurred very quickly. When Starship first stage (booster) B9 in the second flight (IFT-2) after successful separation of the second stage (Ship) began to perform a return braking maneuver (boostback), then, as can be seen from Fig. 1, the booster acceleration (thick yellow line) obtained in this graph by differentiating the speed shown in the video began to change extremely quickly. In this mode, in contrast to the acceleration stages, when the pitch angles are small and in a first approximation it isn't possible to distinguish between total and longitudinal accelerations of the vehicle, it is necessary to take into account not only the acceleration module, but also its direction, which changes to the opposite during boostback.

When analyzing booster characteristics during the return maneuver, it should be taken into account that in Fig. 1, all accelerations are presented in the original coordinate system. But, as will be shown below, at a time interval of approximately 170 – 180 seconds, booster rotated around its transverse axis by 180° (see Fig. 2, 3), and in its own coordinate system, accelerations and overloads changed signs.

Then the average centrifugal acceleration in the zone of interest to us will be  $\sim 1 \text{ m/s}^2$ , and the tangential acceleration from spinning the booster will be about  $1.5 \text{ m/s}^2$ . These values are quite small compared to the longitudinal acceleration values shown in Fig. 1 and reaching up to  $25 \text{ m/s}^2$  in quasi-stationary segment of flight with braking. Since the estimate of centrifugal acceleration is about 4 % of this value, it can be completely neglected in a first approximation. But the tangential acceleration, directed normal to the vector of the main, longitudinal acceleration, despite its relatively small value – about 6 % of it, is the source of effect that can be observed in video [5] – engine shutdown, asymmetrical relative to the longitudinal axis of the booster, well visible, for example, in Fig. 3, so we will take it into account explicitly.

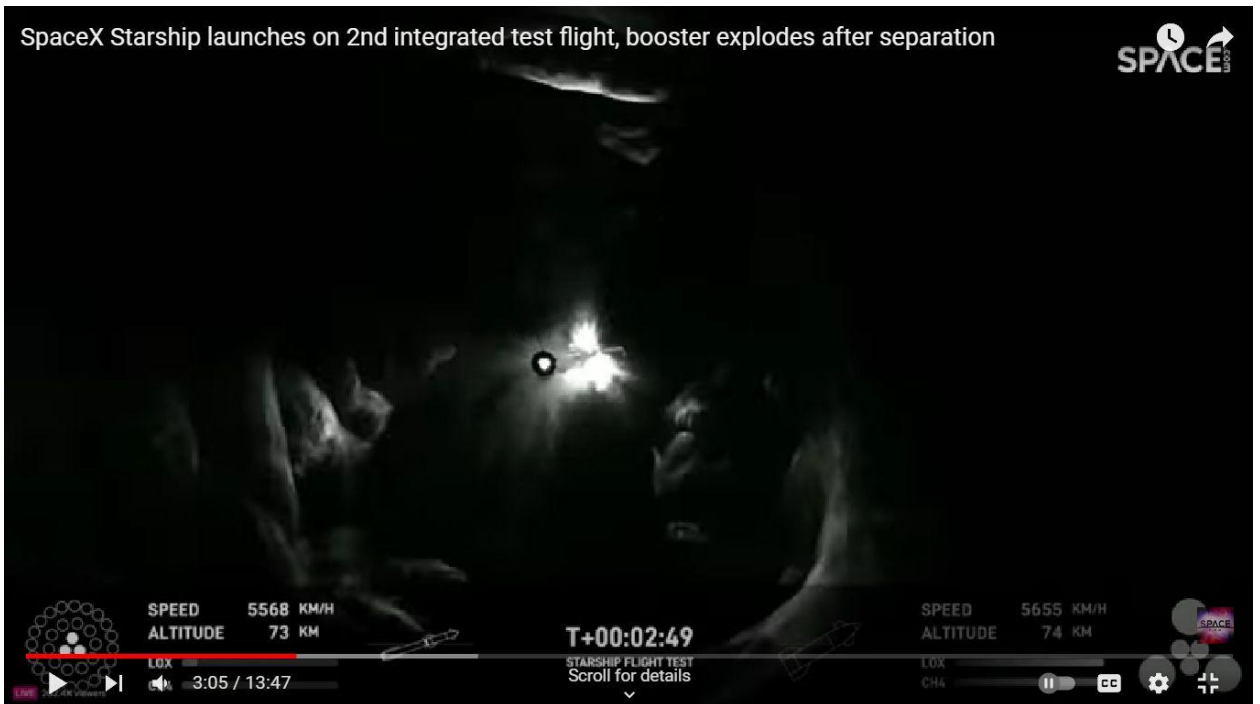
**Fig. 2 – The moment of stage separation, the longitudinal axis of the booster approximately coincides with the direction of system flight**

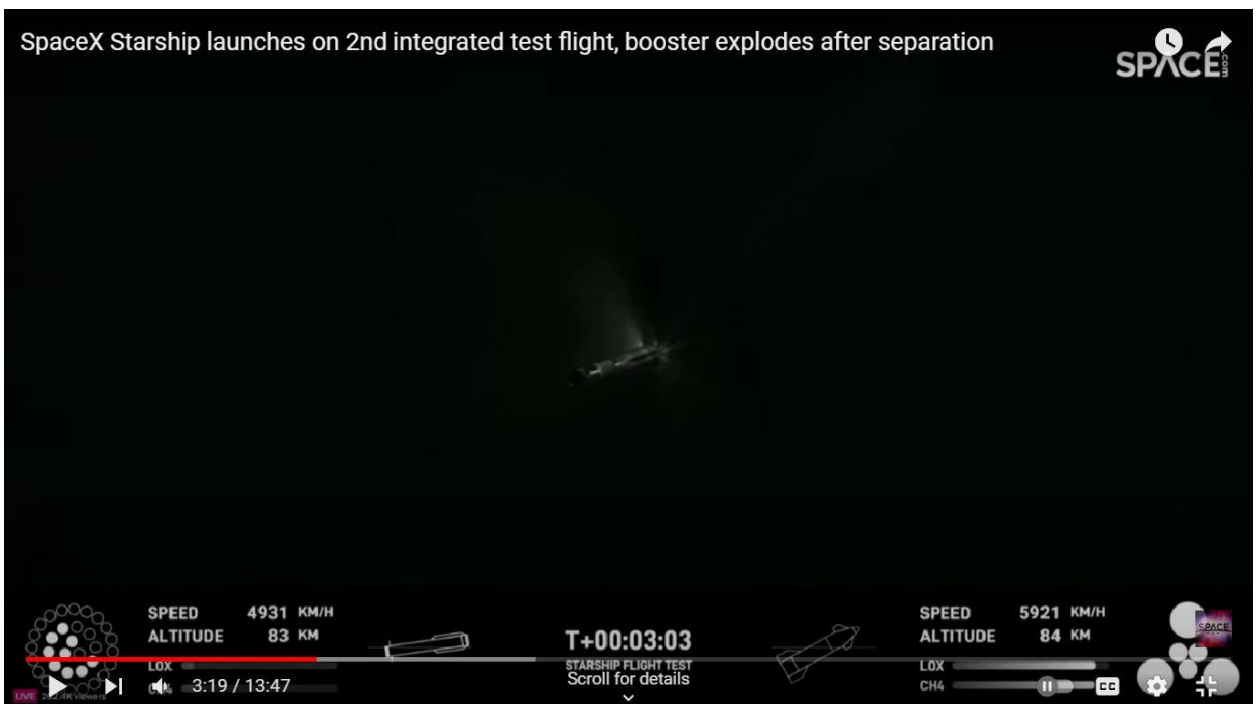
**Fig. 3 – Booster made half a revolution around its transverse axis, turning around to return to the start vicinity**

As can be seen from Fig. 3, by the moment of time shown on it (by 183 seconds, or, more precisely, 5 seconds before that), 3 of the engines restarted during the turn of the stage had already turned off, and all of them, together with the fourth, which didn't turn on, ended up on the same side of the booster.

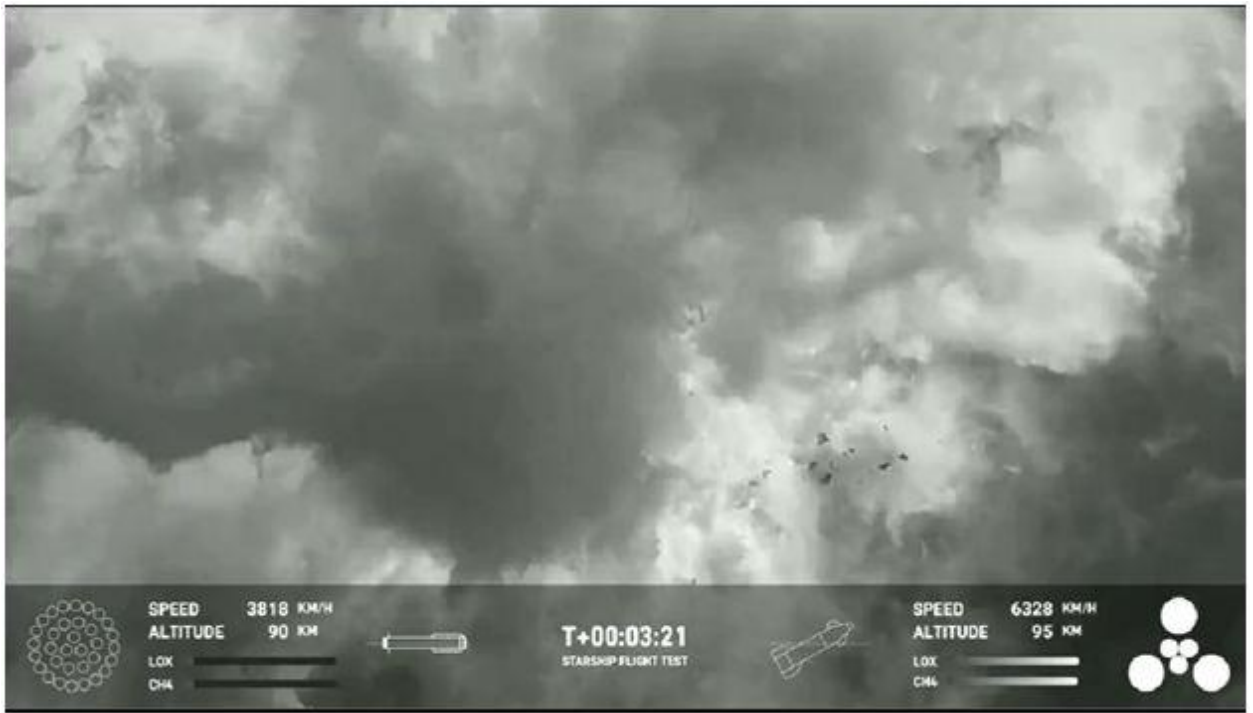
**Fig. 4 – View of the sky one second after the first stage explosion**

Then, the braking mode began without sudden maneuvers and changes in parameters of power plant, which, according to the plan, with 13 operating engines, was supposed to last up to 227th seconds [1]. But, in fact, 9 engines worked on it for only ~10 seconds, and then in 6 seconds, from 191th to 197th seconds, they all turned off. At the same time, at 194th and 197th seconds, 2 powerful lateral flame emissions were noticed from the same area of the engine compartment, and all this ended with the explosion and destruction of B9 stage at the beginning of the 200th second of flight [5], see Fig. 4.

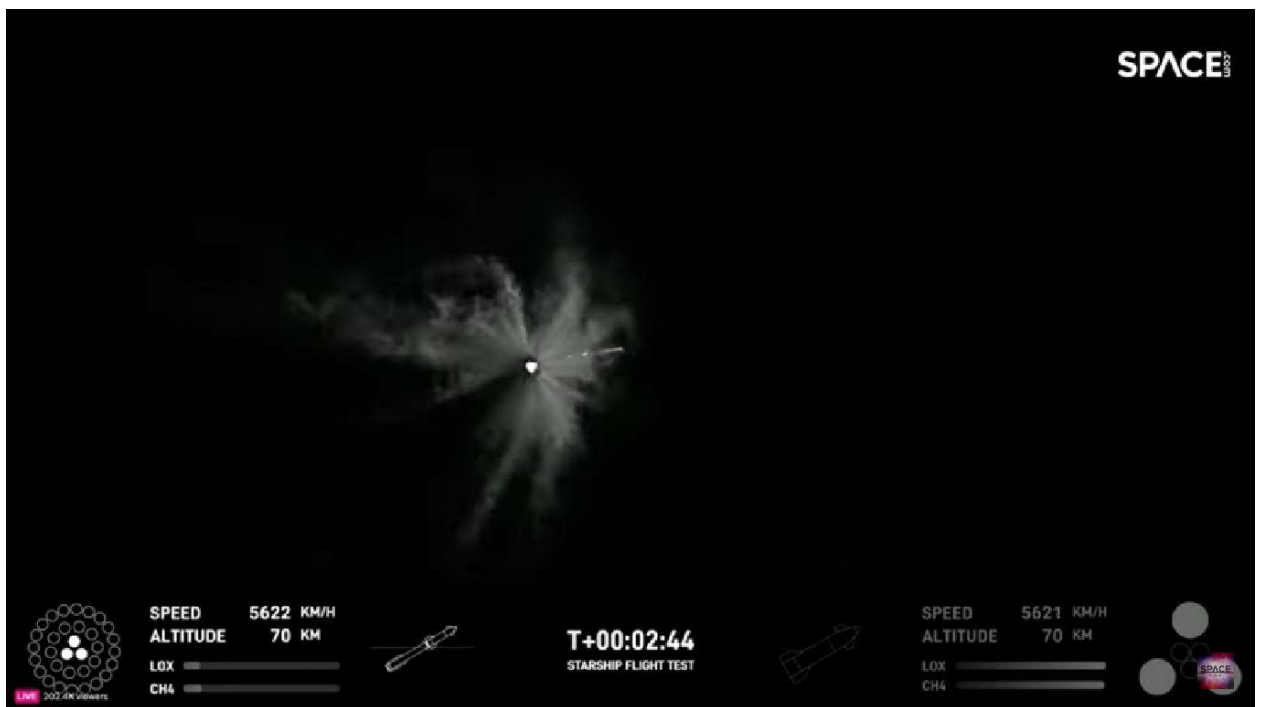
**Fig. 6 – Removal of boost gases from fuel tanks before staging beginning**

It is possible that if all 13 engines were running, the degree of throttling would be higher than during IFT-2. But, in any case, it is clear that before restarting booster engines, in order to prevent rupture of the propellant tanks, it was necessary to greatly and quickly reduce the boost pressure, especially in the methane tank. This could only be done by venting the boost gases into the external space. And on the second flight it was actually done. The video frames clearly show how, in the interval of 163 – 168 seconds, a huge "flower" suddenly "bloomed" around Starship, see Fig. 6. It was formed by tiny droplets of water, condensed after the expansion of boost gases almost into a vacuum, as well as, possibly, droplets of methane and oxygen, and "snowflakes" of carbon dioxide. For some reason, few of the countless number of commentators paid attention to this bright spectacle. This pressure release stopped 1 second before stage staging began. It may be noted that a faint resemblance of this phenomenon was once again observed around the second stage at 460th seconds of flight.
