Causes of Starship both stages crashes on second flight

Yu. I. Lobanovsky

Summary

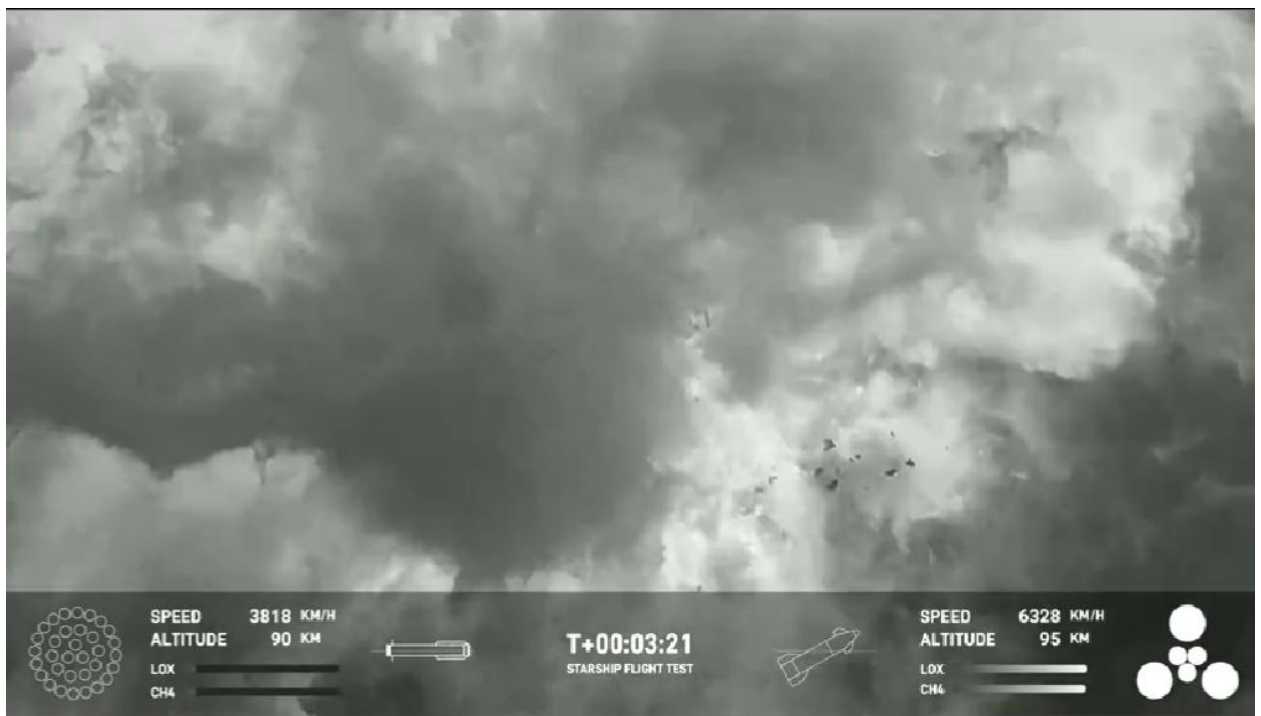
Fig. 3 – View of the sky one second after the first stage explosion

Thus, zone of negative accelerations shown in Fig. 1 from 173 to 199 seconds, was in fact a zone of large positive accelerations caused by the engines working to brake an almost empty stage. Moreover, their operating conditions were quite normal – fuel was very tightly pressed to bottom of tanks, and the stage had already started more or less straight flight with an approximately constant overload of +2.5 g. In general, this differed little from the flight mode that successfully completed just 20 seconds before. However, after 8 – 9 seconds, the 9 remaining engines by that time suddenly began to quickly turn off one after another, seemingly already under normal operating conditions, and when the last one turned off, an explosion and destruction of stage B9 occurred, see Fig. 3, showing what was visible in the sky at 201 seconds [3]. This is all very similar to the fast-paced Pogo excitement.

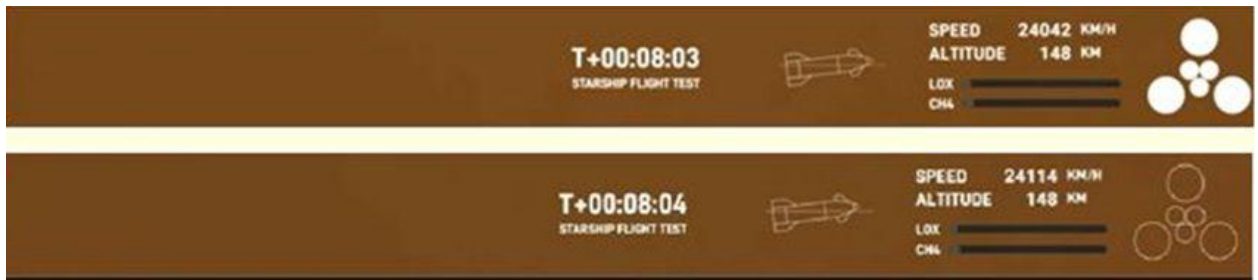
It remains to answer the third question: "Why, without any apparent reason, at the end of the acceleration phase did all the second stage engines suddenly switch off after their long and stable operation?" In Fig. 4 we can see a reflection of this situation on the iconography from IFT-2 video – at the time of 00:08:03, 30 seconds before the planned shutdown, all 6 engines are working, which they have been doing for 322 seconds without any problems, and at 00:08 :04 they all suddenly switched off [3]. After this, one could observe a rather transparent, but still clearly visible plume spreading in the sky, indicating the destruction that occurred on board the second stage, which led to the release of propellant components.

Fig. 4 – Switching off the second stage engines
