# Analysis of Starship third and fourth flights main results

Yu. I. Lobanovsky

## Summary

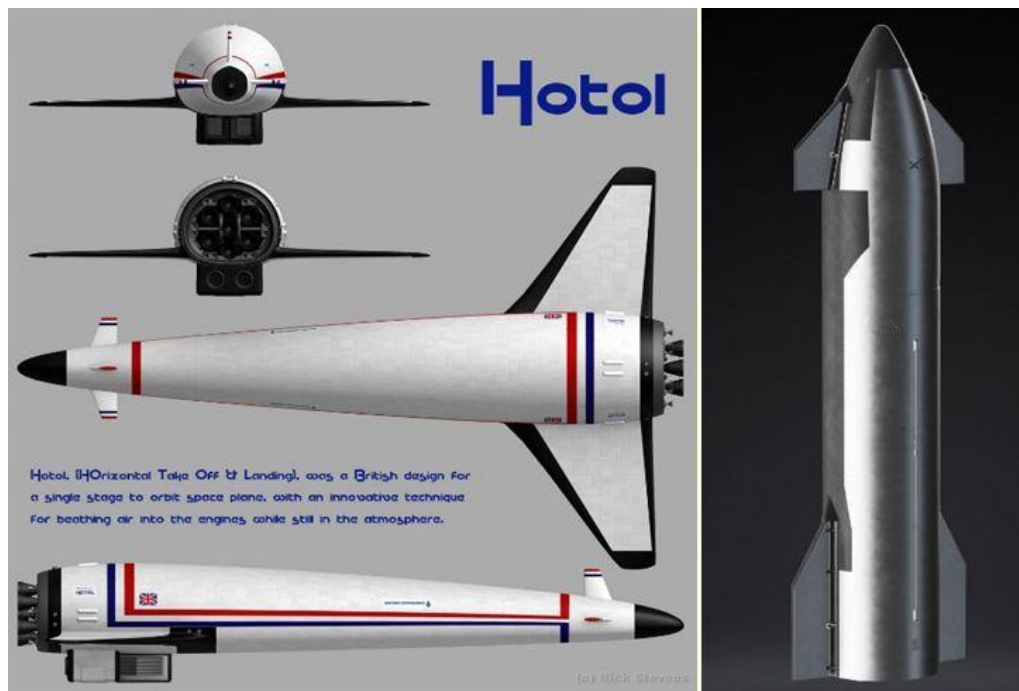
From the above it should be clear that if the body has wing surfaces in the area of its nose in the middle diametrical plane, then the bow shock will fall on them, creating narrow zones of abnormally large heat flows, and it is fundamentally impossible to protect them from overheating. If these surfaces are transferred upward into the aerodynamic shadow, then the part that is inside the bow shock will create small aerodynamic forces and moments, and the part of the surface that protrudes from behind it will be cut off by it. Such configurations are fundamentally unviable at high hypersonic speeds.

**Fig. 5 – Hotel reusable orbital aircraft project (left) and Starship second stage (right)**

Fig. 5 shows an image of the British Hotel single-stage-to-orbit aerospace plane with a combined air-breathing and rocket engine (developed in 1982–1991) [13] and Starship second stage [14] (the most early version of Hotel is shown here). What is important to us is that the configurations of the objects under consideration are qualitatively similar: both have canards for balancing and tail wing surfaces: Hotel has a wing for horizontal landing, and the second stage (Ship) has a tail for balancing. Hotel was never built, but the project developed for 9 years, and it is quite indicative of what its final aerodynamic configuration ended up being. Ship returned from orbit for the first time on June 6, 2024, and it is easy to see that the conclusion from the analysis of these two completely different programs on the issue of interest to us now is quite obvious.

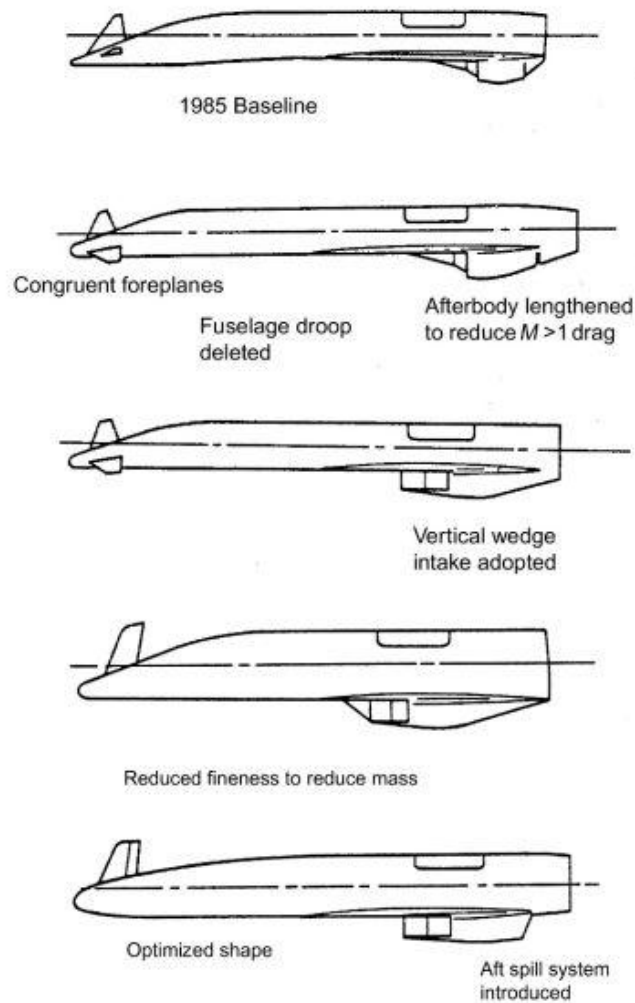
**Fig. 8 – Transformation of aerodynamic configuration of Hotol orbital aircraft during 1985**

Thus, it is absolutely clear that such geometry of the second stage is absolutely inadequate, and the vehicle with such forward tail will never fly normally. The developers of Hotel system gradually came to the same conclusions. Fig. 8 shows (looking from top to bottom) how during 1985 the forward horizontal flaps disappeared. It was replaced by extensions in front of the wing. The vertical tail remained in 1985, but due to the fact that it was in the aerodynamic shadow zone, it grew in size [17].

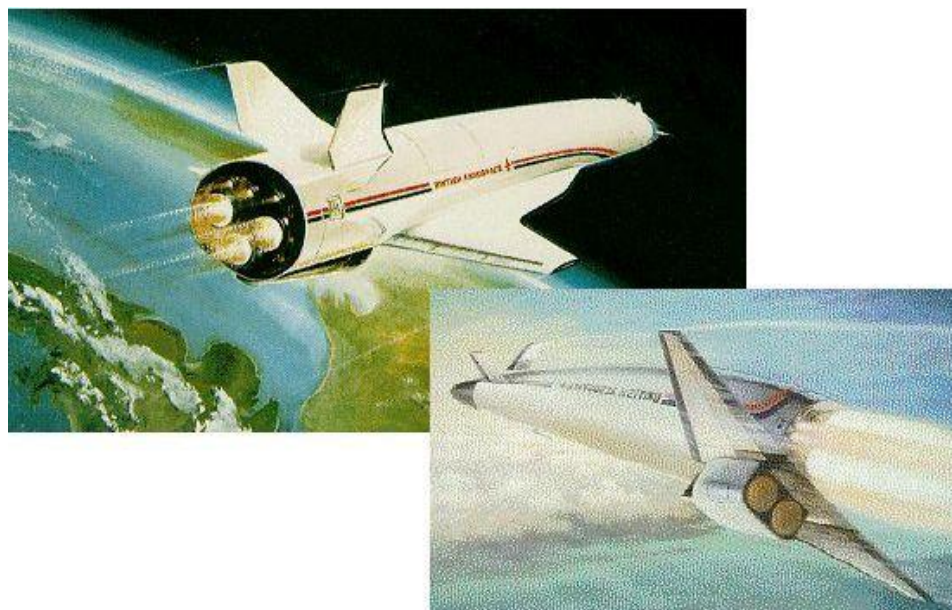
**Fig. 9 – Initial (bottom) and final (top) layouts of Hotol orbital aircraft**

But, in the end, it had to be removed back, clearing the nose from any wing surfaces [17], see also Fig. 9 [18]. Since it is obvious that SpaceX didn't have and doesn't have qualified aerodynamicists in the field of hypersonic speeds, it will probably they come to something similar after many test flights and a lot of time. And only then will regular, rather than test, flights of reusable Starship become possible.

6. Therefore, the used configuration of the forward flaps is completely inadequate and must be changed, what is more shifting it upward into the aerodynamic shadow zone will not lead to any significant results.
