Second crisis of Starship program

Yu. I. Lobanovsky

This paper shows that failures of Starship second stage – Ship Block 2 in the last two flights occurred for two different reasons. In the seventh flight, this happened due to the occurrence of transverse fluctuations of new design pipelines for feeding methane to the external engines with vacuum nozzles, and in the eighth – due to the occurrence of longitudinal auto-oscillations of Pogo-type with hydroacoustic fluctuations in the oxygen feeding lines.

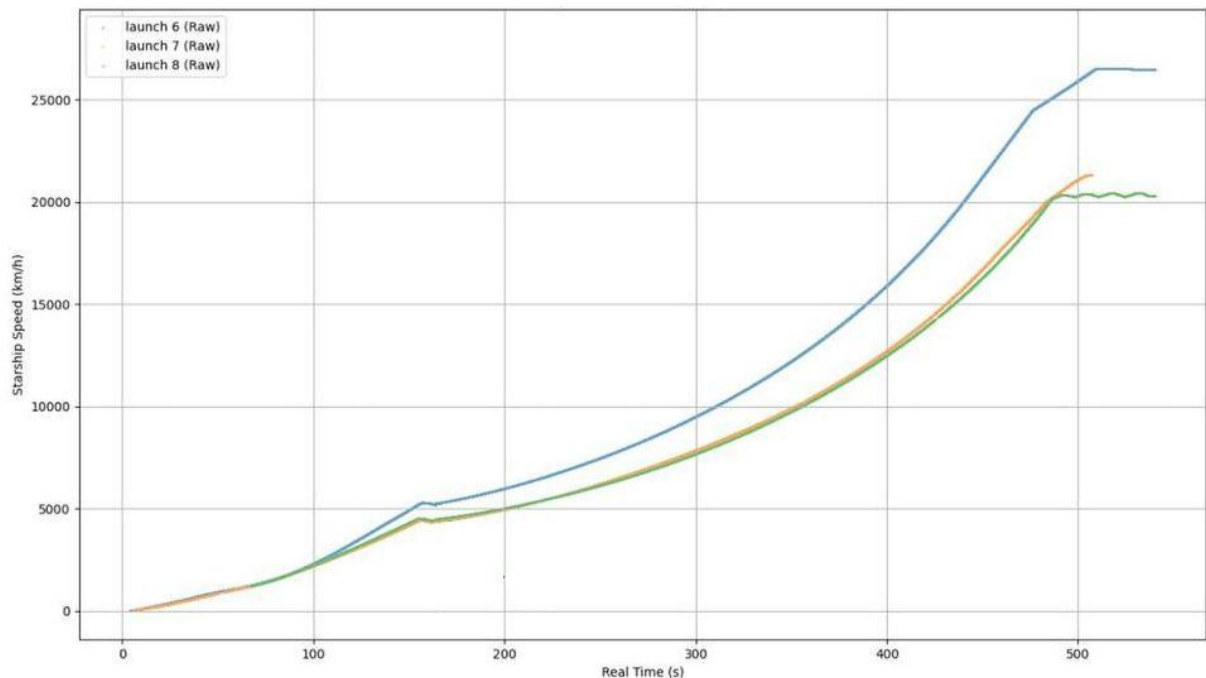
Fig. 1 – Ship speed in the last three flights (IFT-6 – IFT-8)

Due to its greater mass and the same power plant, new version of Ship accelerated more slowly than the old one. On the eighth flight, at least in the final phase of acceleration, the power plant thrust was slightly reduced compared to the thrust of the previous flight, but in both cases flights ended with the destruction of the second stages.

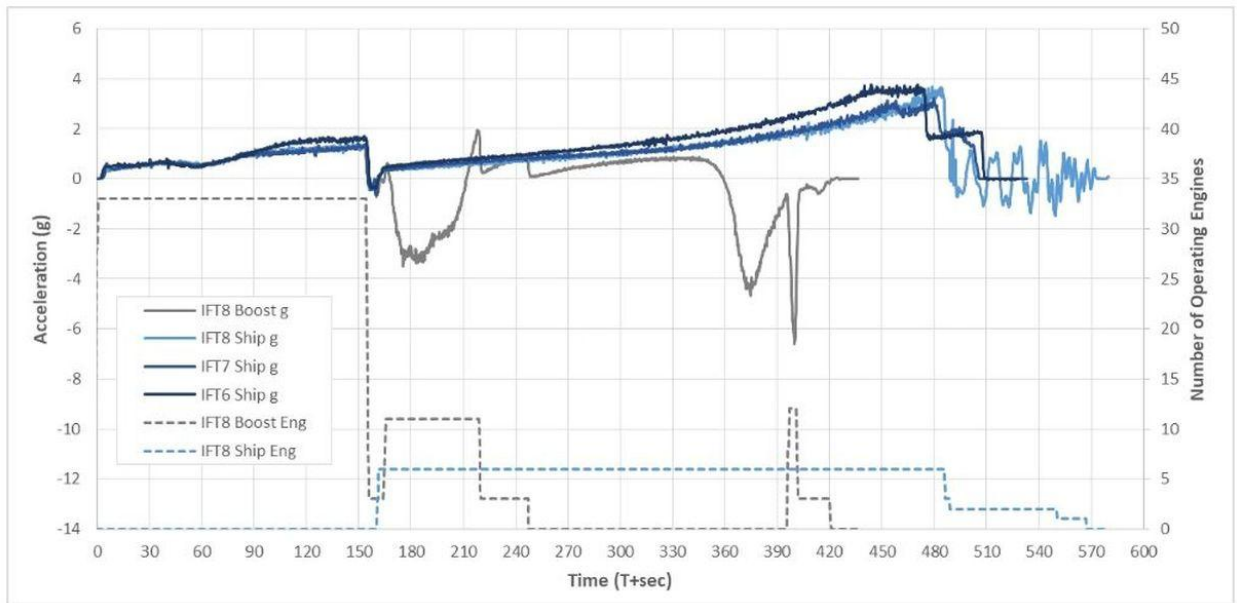
Fig. 2 – Starship system accelerations in the last three flights (IFT-6 – IFT-8), as well as booster acceleration and the number of operating engines in the eighth flight (IFT-8)

Let us now return to Fig. 1, 2. The second stage acceleration in the sixth flight was traditionally completed by switching off three external Raptor-2 engines with vacuum nozzles, specially designed for operation in these conditions, 15 – 30 seconds before reaching the required speed. This was due to the fact that a little later in time they would enter pogo excitation zone. At the same time, a kink appeared on the speed graph, and potential payload was reduced, but in these launches, unlike the second, seventh and eighth flights, there was no explosions at the finish of the acceleration section. Moreover, with each flight from the third to the sixth, the time for switching off the external engines increased.
